## Bearing failures: When normal readings hide the risk

A serious engine-room incident shows how quickly a local bearing failure can escalate – even when standard temperature and pressure readings appear to be normal.

Published 07 September 2026

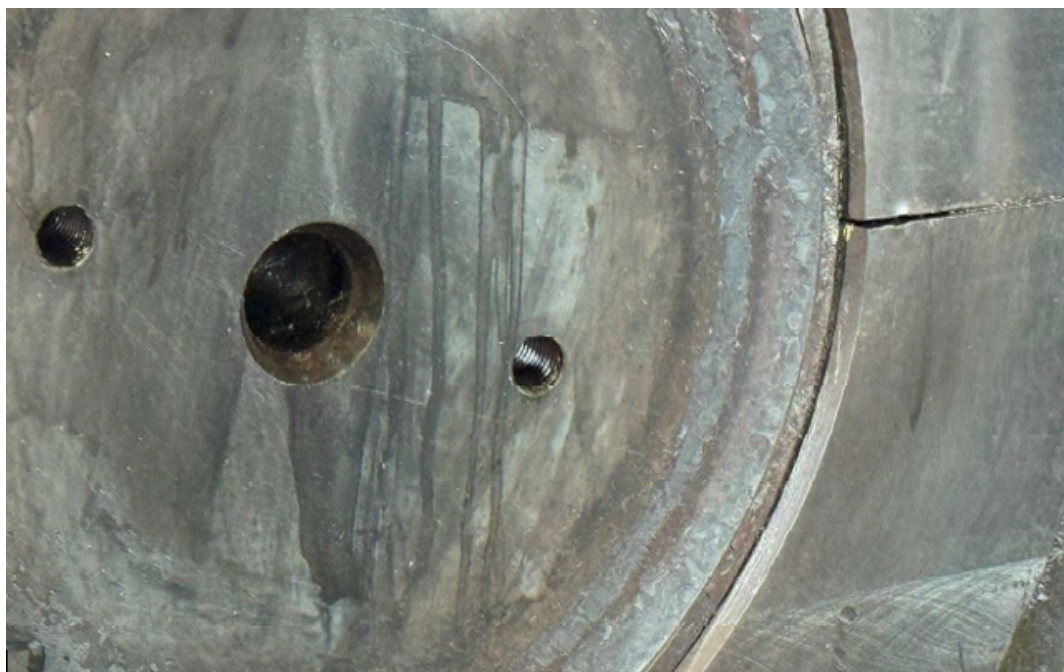
The immediate cause was identified as the failure of the aft bearing on the upper intermediate gear. The bearing shell failure led to metal-on-metal contact and rotation of the bearing shell in the gear bearing housing. The rotation of the shell closed the oil inlet bore, cutting lubrication to the bearing. With no oil supply, the excessive friction generated heat, creating a hotspot and catastrophic bearing damage.

Upper intermediate gear severely affected by heat due to friction. Source: Brookes Bell.

This case highlights the limits of conventional engine parameter monitoring. Effective condition monitoring should combine additional temperature measurement trends with information from oil mist detectors, lubrication systems, vibration monitoring, alignment checks and physical inspections.

The maritime industry is increasingly introducing [enhanced bearing-monitoring systems](#) . These can measure additional bearing temperatures in real time and trigger alarms, automatic load reduction or engine shutdown when abnormal temperatures or trends are detected. Such systems can help prevent overheating, engine damage and costly downtime.

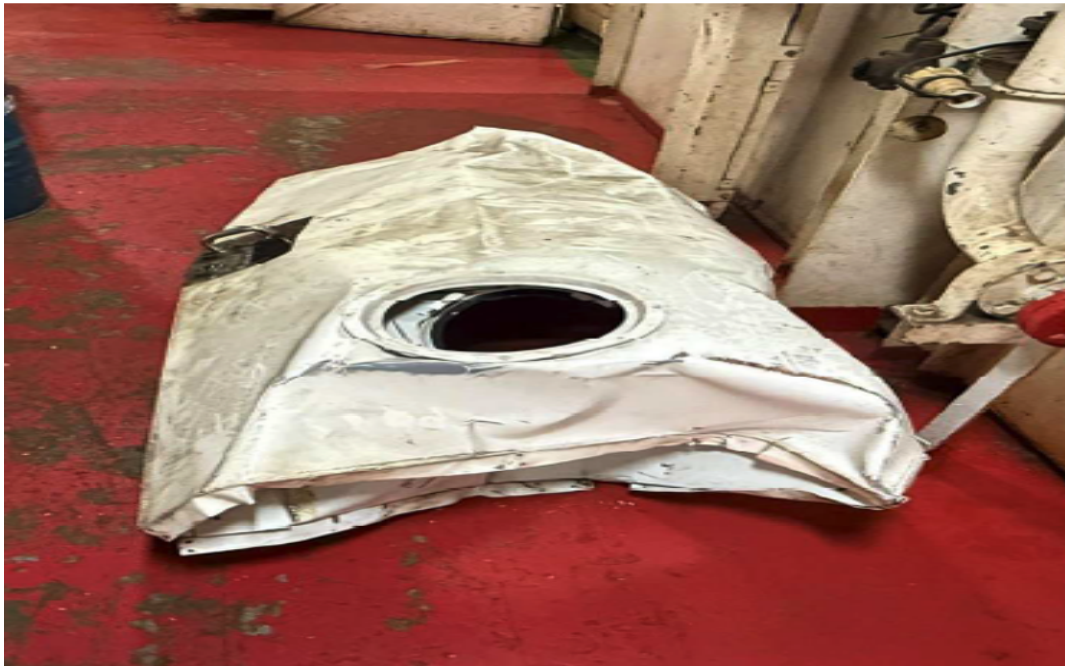
The heat development created a flammable oil mist in the upper crankcase, an area not protected by oil mist detectors. When the mist ignited, the resulting crankcase over-pressure activated the crankcase relief valves. Eighteen engine-room doors buckled and were displaced from their hinges.

Engine room doors severely damaged from pressure after crankcase deflagration.  
Source: Brookes Bell.

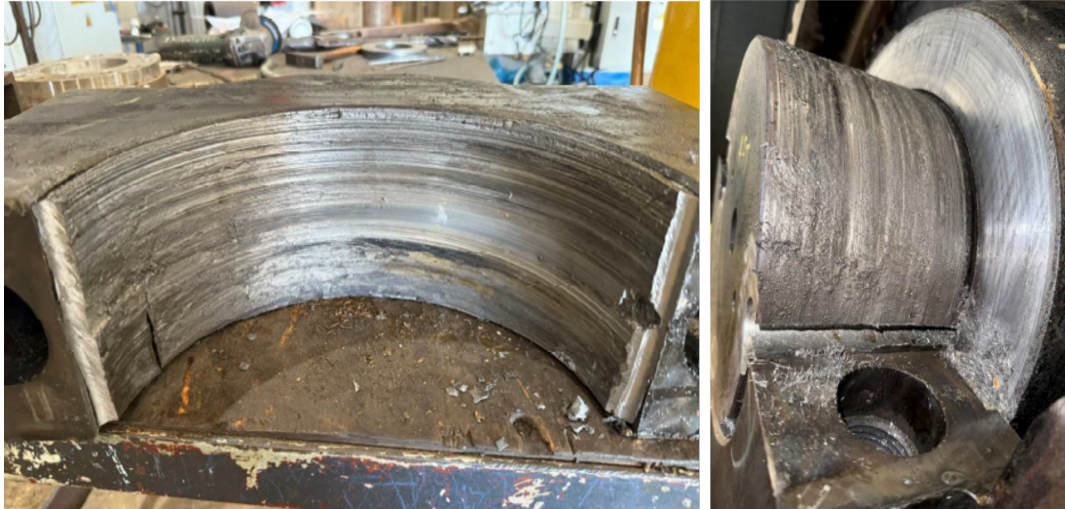
Left: Upper intermediate bearing after removal from the upper intermediate shaft.  
Right: Upper intermediate shaft after removal of bearing saddle. Source: Brookes Bell.

The investigation found no evidence of poor maintenance, oil contamination or restricted oil supply. The oil bores and piping were clear, and oil samples were within acceptable limits. Misalignment was also ruled out, and wear on the gear teeth was normal. The damage was limited to the aft gear bearing, while the other bearings in the same lubrication system were unaffected.
