Rise in fishery claims in South Korea waters

Gard has observed a rise in navigation incidents involving fishing nets over the past year. Our correspondent, KOMOS, reports that issues with offshore stow nets remain persistent, largely due to minimal restrictions on where this gear can be installed outside of designated anchorages and prohibited fishing zones.

Published 06 July 2026

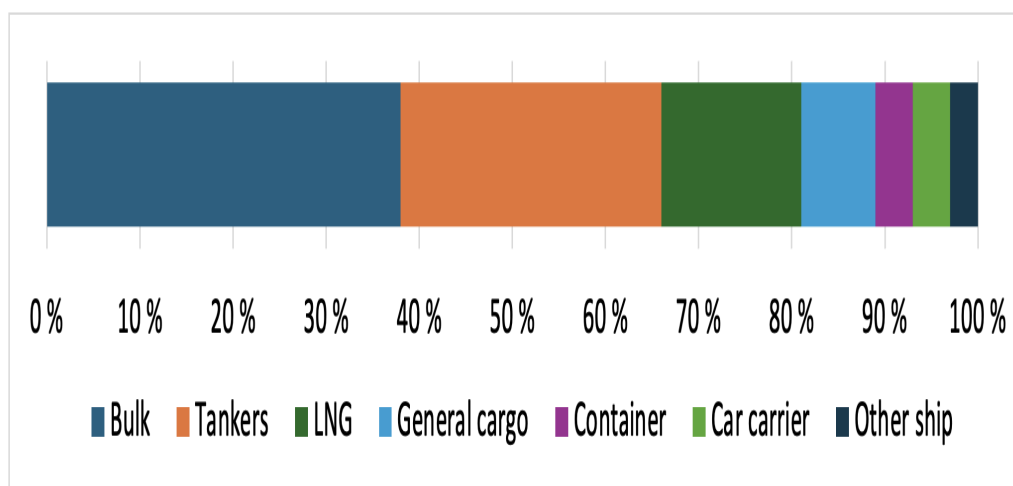
Incidents by vessel type

Bulk carriers accounted for nearly 40 per cent of the vessels involved in these incidents, followed by tankers at 28 per cent, LNG carriers at 15 per cent and General Cargo at 8 per cent. Notably, liner vessels (container and car carriers) represented the smallest share, accounting for a combined 8 per cent.
