## Rise in fishery claims in South Korea waters

Gard has observed a rise in navigation incidents involving fishing nets over the past year. Our correspondent, KOMOS, reports that issues with offshore stow nets remain persistent, largely due to minimal restrictions on where this gear can be installed outside of designated anchorages and prohibited fishing zones.

Published 06 July 2026

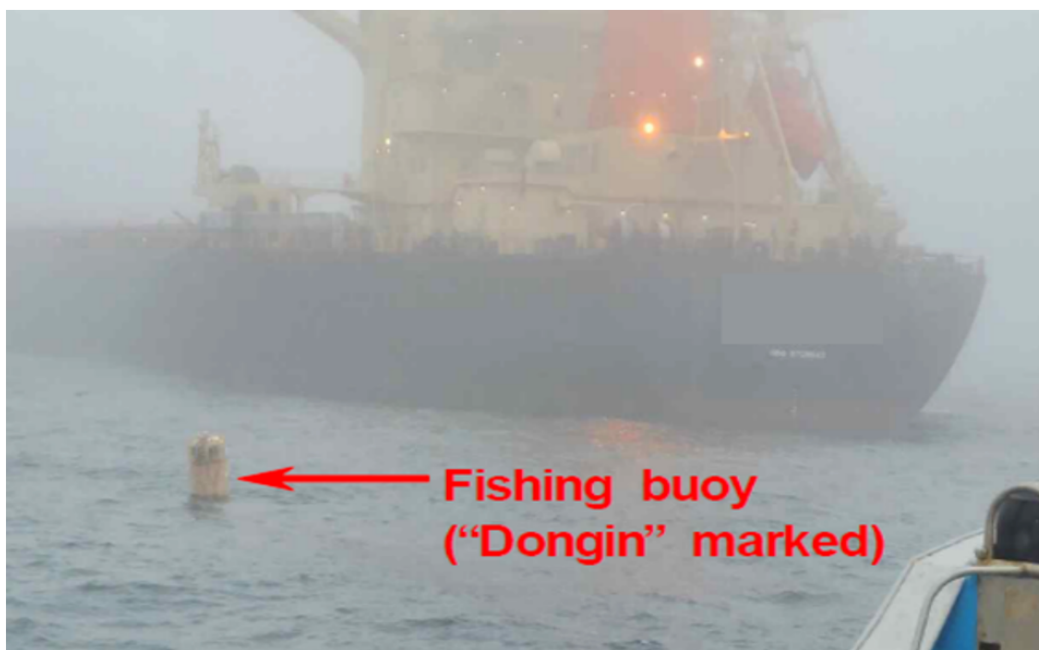
- Under stow net fishing permits, owners are required to install warning markers, such as flag poles or floats, to alert vessels in the vicinity. While crews involved in these incidents frequently report that they observed no surface markers, our experience indicates that the nets are almost invariably protected by these required marking floats, as shown in the image below. It is worth highlighting that even when damage is caused to unauthorized aquaculture facilities, local courts generally still recognize these as valid property damage claims.
