Liquefaction of chromite ore originating from South Africa

Despite being categorized as a ‘Group C’ cargo in the International Maritime Solid Bulk Cargoes (IMSBC) Code, Gard’s recent experience in South Africa suggests that chromite ore may exhibit Group A properties including the potential to liquefy.

Published 15 August 2024

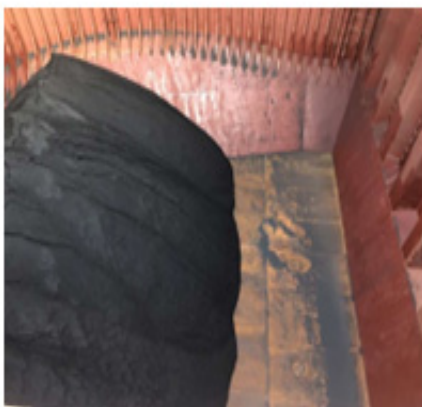
The vessel had loaded a parcel of Chromite Ore at Durban in cargo hold no. 1 and proceeded to sea while waiting for subsequent parcels to be loaded. The cargo had been declared as Group C with no declared moisture content (MC) and transportable moisture limit (TML). While waiting for further cargo, the Master reported that the cargo was showing signs of liquefaction. Investigations revealed that the cargo was fine particles and had flow potential. Recent heavy rains likely contributed to the elevated moisture content in the stockpiles, which were exposed to the elements. The shippers provided an updated cargo declaration, where the name of the cargo was amended from “chromite ore” to “Chromite Ore (metallurgical grade concentrate)” and Documentation for MC and TML was provided as well, although the cargo was still declared as Group C. The vessel was subsequently detained by South African Maritime Safety Authority (SAMSA). The detention note stated *“Cargo had shifted rendering the vessel unseaworthy, and cargo information provided before loading did not match the cargo loaded onboard”*.

Upon completion of loading first parcel

- It is crucial to engage charterers in early discussions if your vessel is nominated to carry chromite ore, as a cargo declaration classifying it as Group C may not be accurate, as seen in the above examples. The cargo may appear to be dry and granular when shipped, however, it may be prone to liquefaction at a subsequent stage. Some signs to look for:
splatter on the bulkhead of the cargo holds,
failed can tests,
fine nature of chromite ore cargo,
recent rainfall in the port,
MC & TML certificates provided but cargo still declared as Group C. Refer to our topic page on [liquefaction](#) for further details.

- The cargo surface should be trimmed completely flat on completion of loading to minimize the risk of the cargo shifting.
- During the voyage, the crew should regularly check the condition of the cargo. Any sign of cargo liquefaction such as flattening, shifting, free surface water, or vessel instability be seen as a need for urgent assistance not limited to seeking safe anchorage.

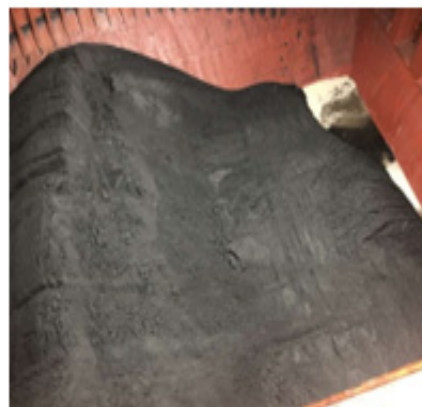
Cargo surface flattened and water accumulation noticed a day later

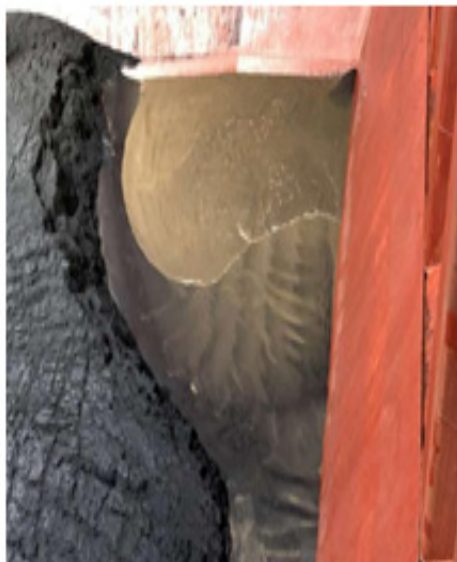
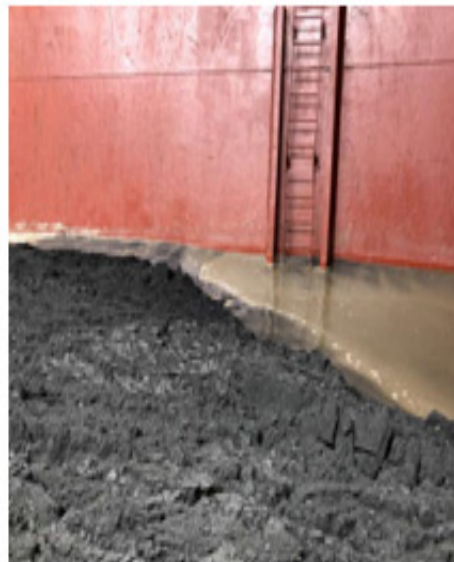
The vessel loaded Chromite Ore at Durban and departed for Maputo. On arrival Maputo, it was noticed that there was a substantial amount of water collected in the corners of the stow in all cargo holds. The presence of muddy and liquefied cargo indicated that the cargo was Group A and not the Group C as was indicated on the shipper's declaration.
