Case study 4

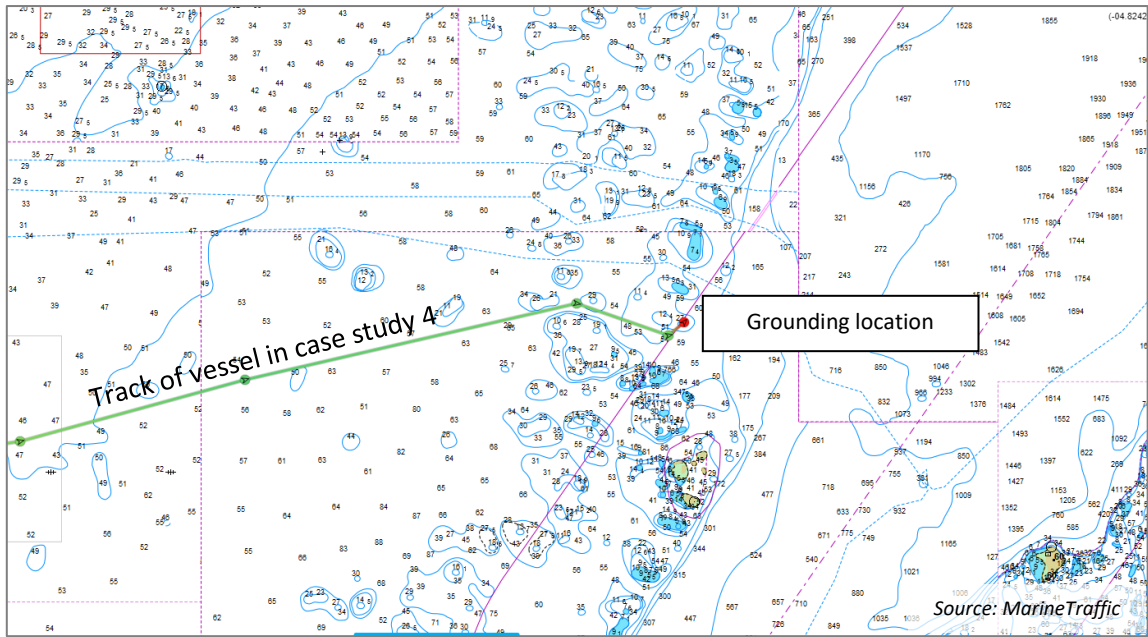
Close up of the area where the vessel grounded on an uncharted obstruction

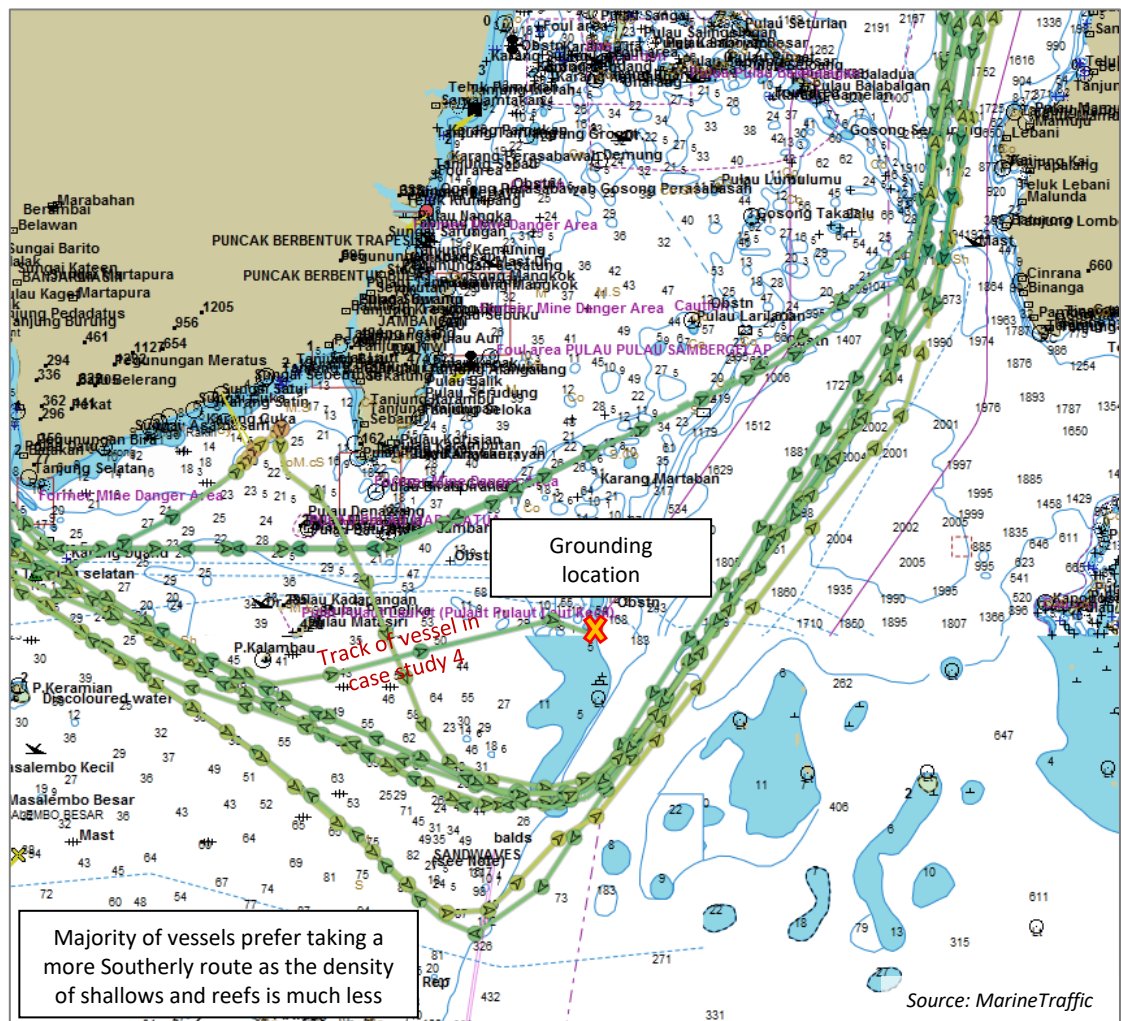
AIS tracks of some of the vessels with a draft between 14 and 15 meters which transited between Makassar Strait and North East Java Sea in the 2 month period before the date of incident
