## Are your hatch covers weathertight?

Published 31 August 2022

Written by Per Haveland

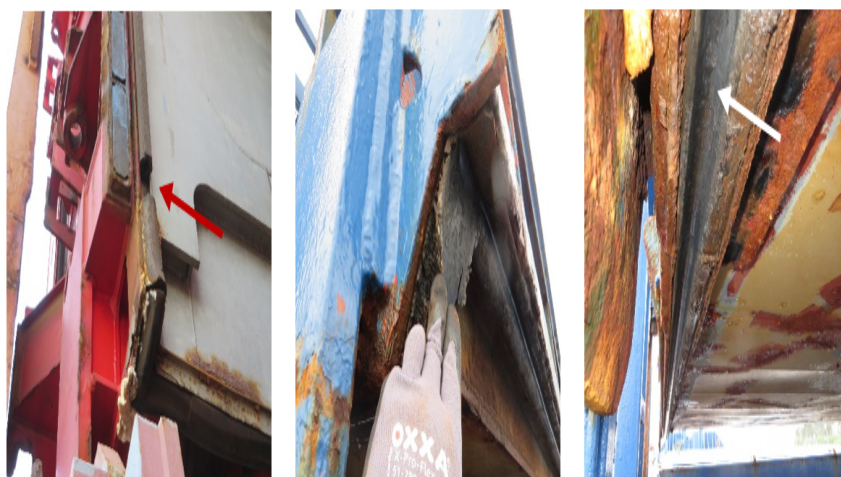
*Gaps between insert repairs*

*Deteriorated rubber packing  
near the edges*

*Permanent set in the rubber  
packing*

**Rubber packing:** This is by far the most commonly noted defect. Whilst physical damage to packing rubbers, e.g. as a result from contact with stevedore's gear etc., is generally easily identified as damage during routine inspections, the equally important ageing and steady deterioration of packing rubbers, caused by abrasion and over compression can get overlooked.

One of things that often gets overlooked is the permanent set or imprint on the rubber packings in excess of the limits mentioned by the manufacturer caused by over compression, over tightness of cleats or worn-out landing pads. This can adversely impact the resilience of the packing rubber. In general, the discard criteria for rubber packing is when the permanent set has exceeded 50% of the design compression, but reference should always be made to the manufacturer's manual.

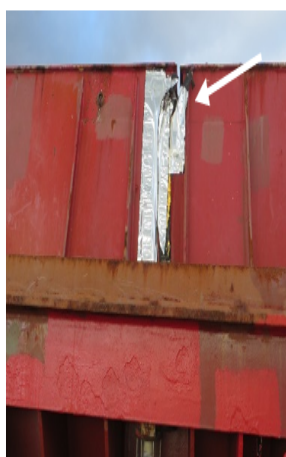
*Ramnek tape*

From a P&I Club's perspective, the use of ramnek /sealing tape and foam is generally not recommended as properly maintained hatch covers are designed to withstand the rigours of sea. Any evidence of ramnek tape or foam can be construed as an indication of defective hatch covers by the cargo receivers to support a cargo claim for wet cargo damage. If a charterer however requires the use of sealing tape or foam, it is recommended that owners have the hatch covers tested (preferably by ultrasonic test) and inspected by an independent surveyor to confirm that the hatch covers are weathertight prior departing the load port. The test and inspection results should be properly documented to show that the Ramnek tape or expansion foam was only used as an extra precaution upon charterer's request.

- If the hatch covers are inadvertently opened before the expansion foam is removed, foam particles can fall into the cargo hold and cause contamination.
- Foam can also block the drain channels and inter-panel void spaces and not allow the water to drain out.
- Ramnek tape and expansion foam are also difficult to remove and may prevent covers from closing properly after completion of the voyage in question.
- When removing Ramnek tape the paint in way of the hatch cover edges will be damaged and can lead to corrosion.
- Expansion foam could cause physical damage to the rubber packing.

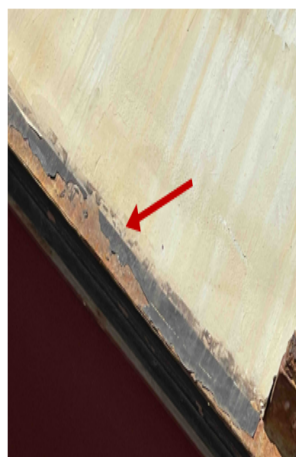
*Evidence of ramnek tape  
from previous voyages*

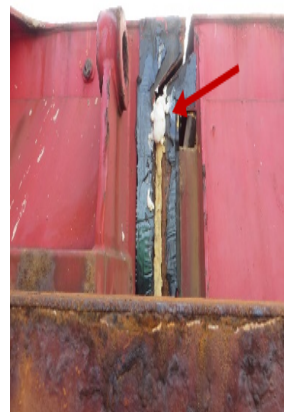
*Foam between hatch covers*
