Grounding incidents in the Indonesian archipelago

Published 07 July 2020

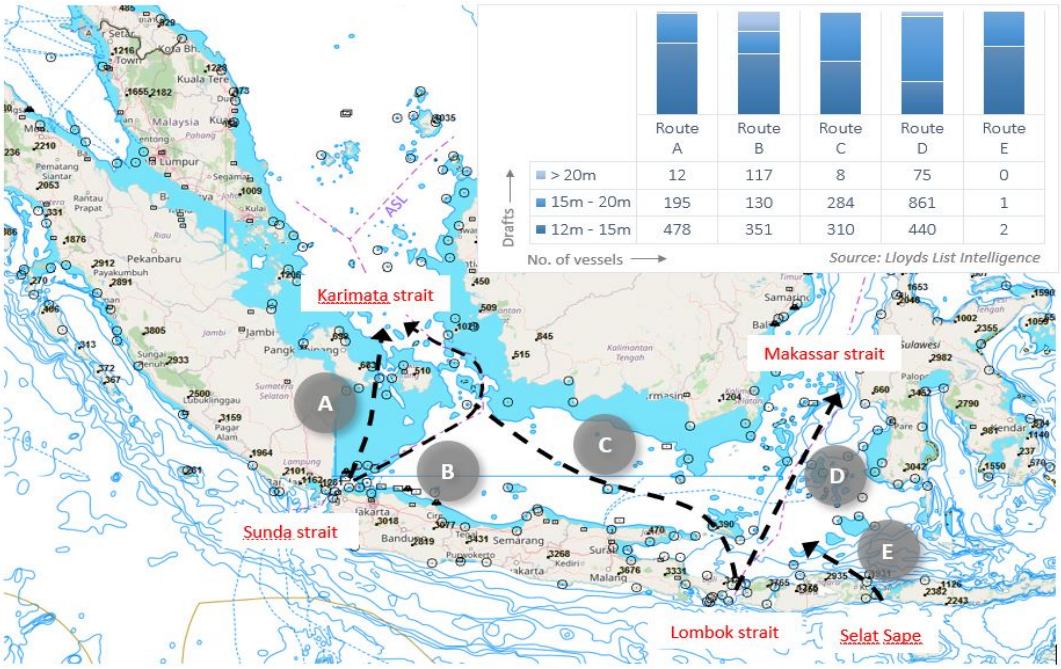
Traffic flows for 2019 (vessels with draft ≥ 12 m)

Traffic data suggests that laden VLCCs and VLOCs also routinely use the passage through Sunda and Lombok Strait in addition to vessels having shallower drafts. The only exception was Selat Sape which was hardly used. Only 3 vessels in 2019 having a draft > 12 meters transited through Selat Sape even though the charted depths are shown to be around 100 meters. We discuss more about this route in our third case study.
