MARS – Lessons Learned

MARS Report No 389 March 2025

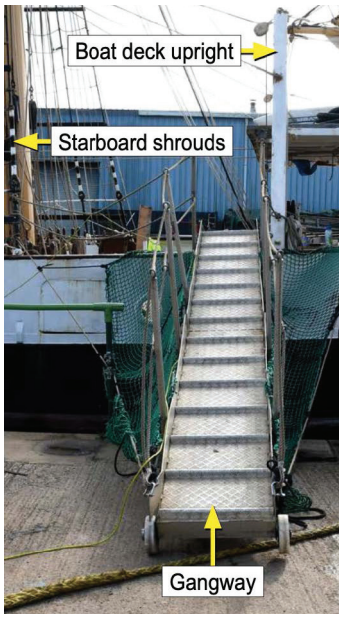
- The vessel's gangway did not provide a safe means of access to/from the vessel. Specifically, inadequate fencing and an inappropriately rigged safety net exposed all gangway users to serious hazard as they traversed the gangway.

Gangway installation with netting each side

- There was a lack of guidance and training for those crew rigging and those inspecting the gangway before use.
- The victim was well above the legal limit of blood-alcohol content for duty on a vessel when he fell from the gangway. It is likely that he experienced cold shock on entering the water and that his state of intoxication hindered his ability to raise the alarm or attempt to self-rescue.
- There were early indications of a problem with the relief cook's alcohol consumption, but this did not result in an effective intervention by his shipmates.

- Safe access/egress to and from your vessel is literally where a strong safety culture starts. Make sure yours is safe.
- One for all and all for one. Look after yourself but also look out for your shipmates.
- Alcohol abuse is usually easy to spot amongst shipmates. Help them get professional help and do not indulge their impaired behaviour.

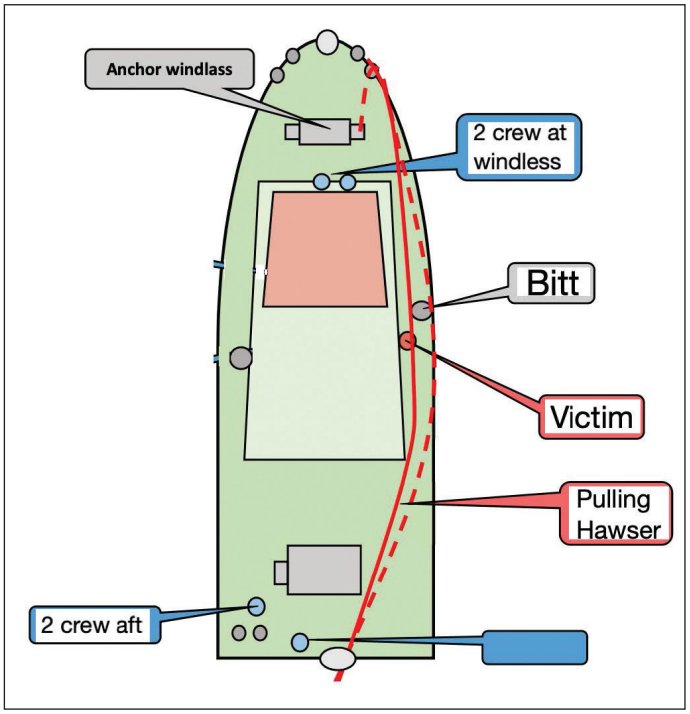
As the tension was brought on the pulling hawser there was a loud sound and pulling was stopped at the windlass. Crew member A was found pinned against the tug's superstructure by the pulling hawser. Unknown to the other crew, who did not have a line of sight to the victim, crew member A had repositioned the pulling hawser back outboard of the bitt. When it came under tension, the pulling hawser slipped off the top of the bitt with accumulated energy and trapped crew member A against the superstructure.

Tow line recovery arrangement and position of crew

- Although the accident investigation was diligent in documenting the accident facts, the analysis is a litany of 'blame the victim'. The victim certainly acted against an agreed procedure by placing the pulling hawser outboard of the bitt, but what about the lack of supervision that allowed this dangerous act?
- The agreed procedure was that no one should be located on the starboard side next to the pulling hawser – yet crew member A was there, to everyone's knowledge, until his untimely accident. Again, what of the supervision?
- Why wasn't the tug's towing winch used for this operation – a safe and straightforward method to recover the towline. The report is silent on this matter and on the dangerous improvised method used.
