Vessel groundings in new Parana channel off Paso Fighiera

Newly opened Parana River channel has seen a spate of groundings since its opening in April 2025.

Published 18 June 2025

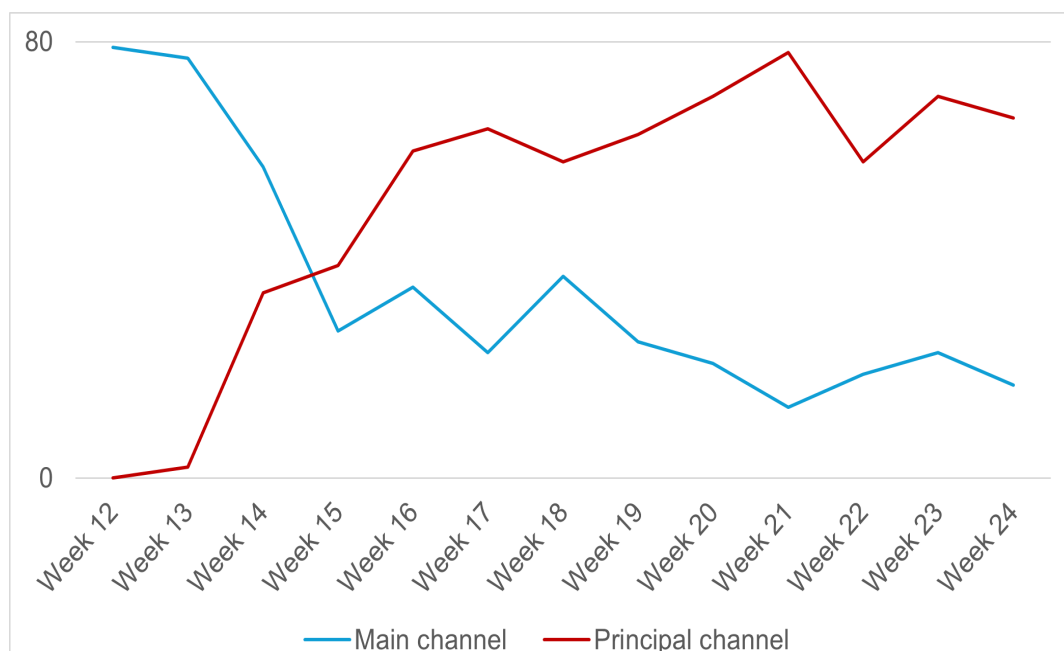
Analysis of AIS data reveals that merchant vessels with a deadweight exceeding 5,000 tonnes commenced transit through the Principal Channel in Week 13 in March 2025. Over subsequent weeks, there was a consistent increase in the number of vessels using the Principal Channel. This period (Week 13 to Week 24) also coincided with a steady decrease in traffic through the Main Channe, as indicated in the below graph.

Number of vessels transiting the two channels. Includes all merchant vessels > 5,000t dwt (Source: Windward Maritime AI TM)

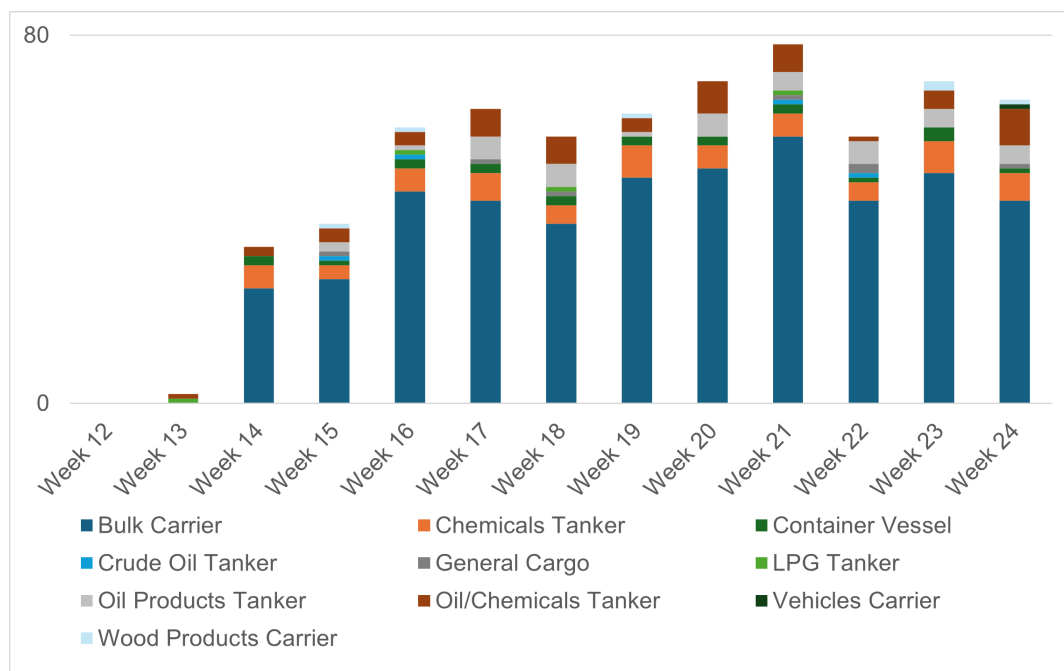
When looking at vessel types using the Principal Channel, bulk carriers - primarily Handysize and Panamax - are the most common, with chemical/oil tankers coming in second, as the detailed chart below illustrates.

Type of vessels transiting the newly opened Principal Channel (Source: Windward Maritime AI TM)
