Learning as we go: challenges with the use of exhaust gas scrubbers

Published 17 October 2019

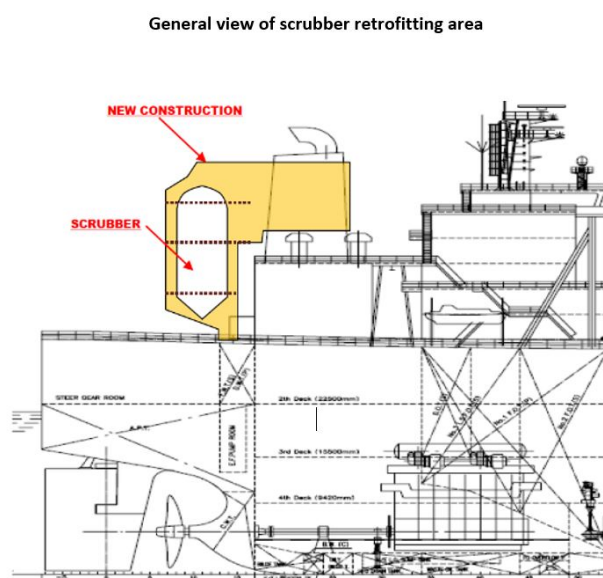
Scrubber installation requires extensive hot work to facilitate the extension of the funnel area and attaching the scrubber tower to the vessel's structure.

Gard has seen a few fire incidents where sparks from welding, metal cutting, and other hot work activities fell into the inner chamber of the scrubber through uncovered openings, and in one case the fire also spread to the engine room through glass reinforced epoxy (GRE) piping. Heat generated from the steel cutting for the supporting brackets, also contributed to the build up of heat inside the scrubber. In all these cases the yard fire fighting team responded and extinguished the fire with vital assistance from crew.
