# ANCHOR AWARENESS

**Jarle Fosen**  
Senior Loss Prevention Executive  
17 November 2021

# ARE MORE ANCHORS LOST NOW THAN BEFORE?

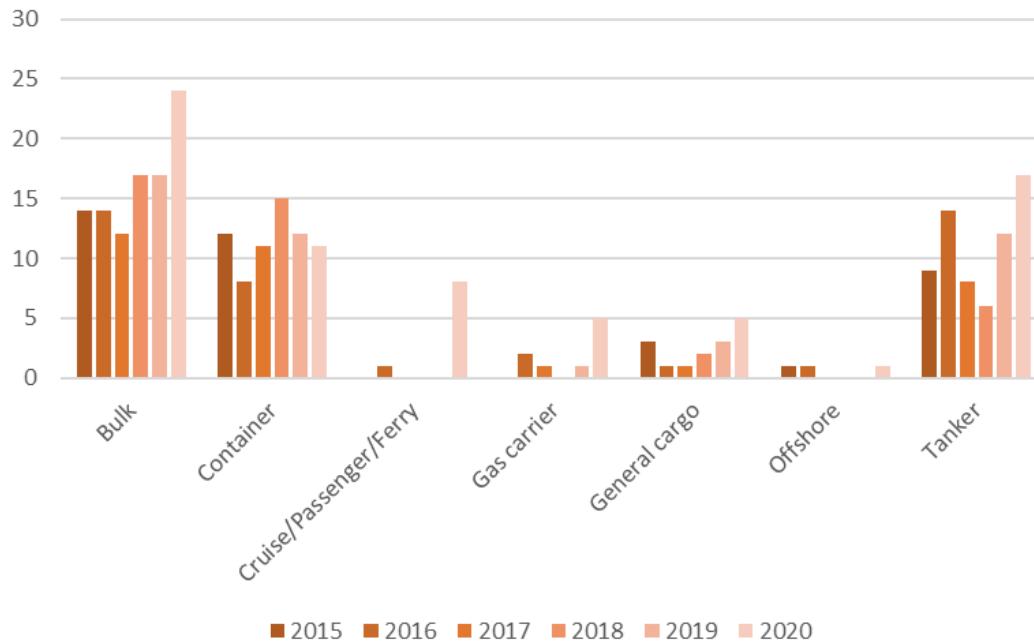
Total anchor losses per segment per year

# WHICH SEGMENTS ARE LOSING MORE ANCHORS?

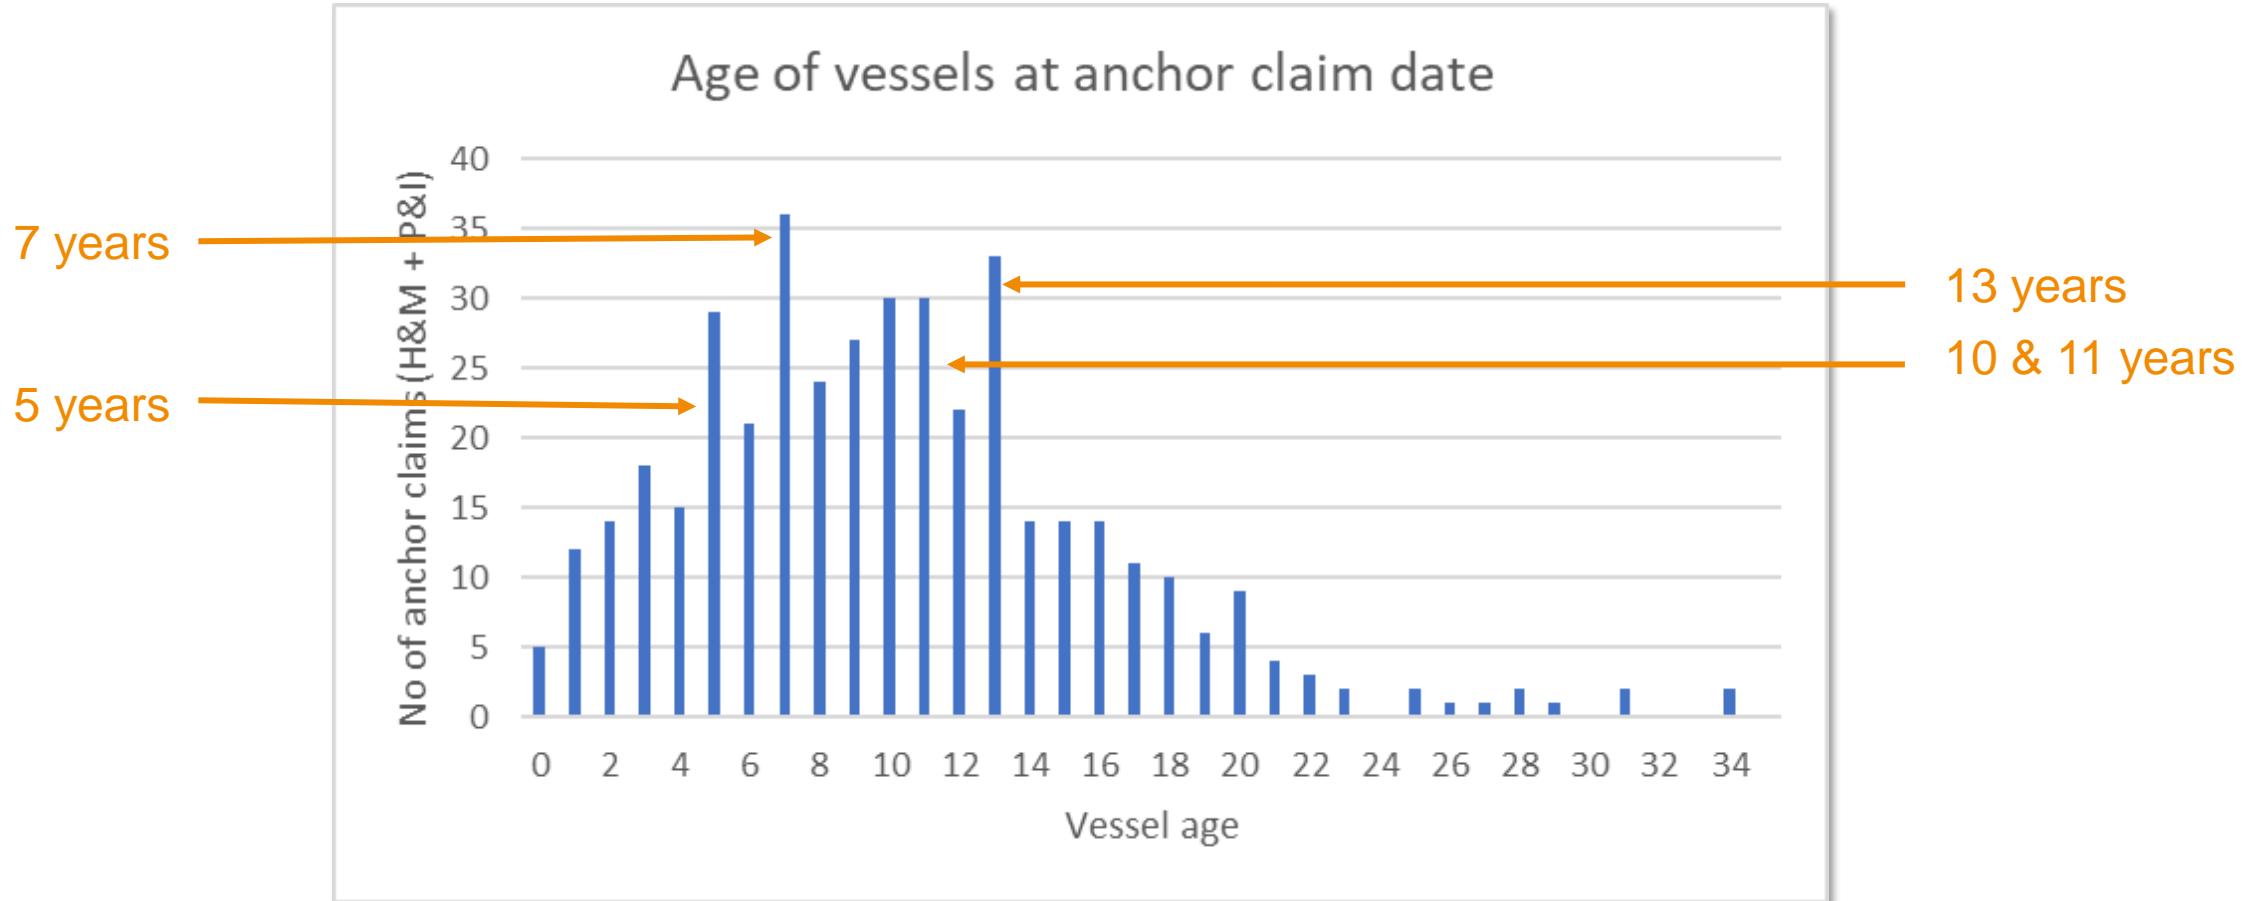
# DOES VESSEL AGE MATTER?

Are anchor losses an early midlife crisis?

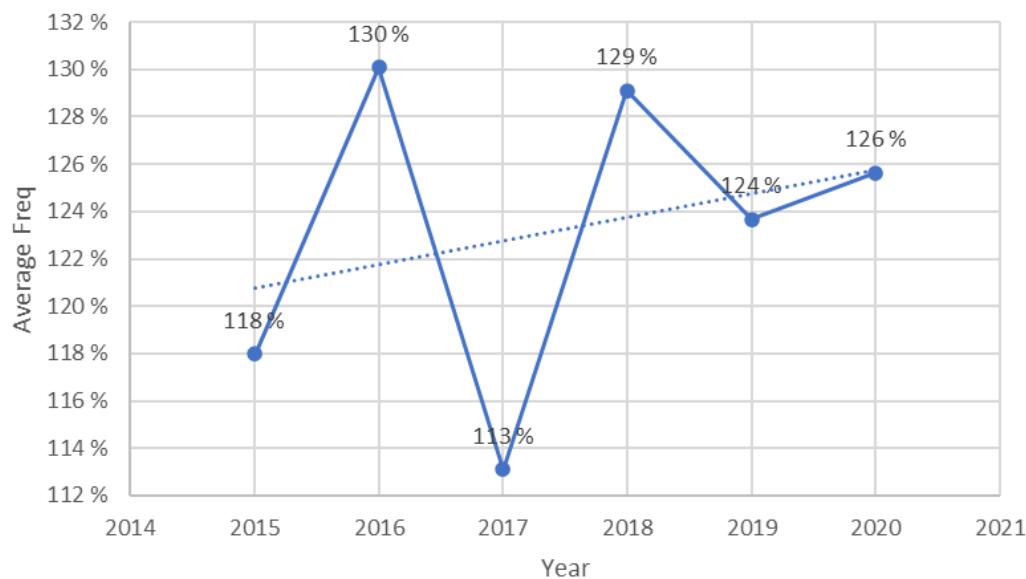
Average frequency of number of times anchored per year

A vessel with an anchor claim, dropped the anchor on average 28% more frequently than a vessel without an anchor claim

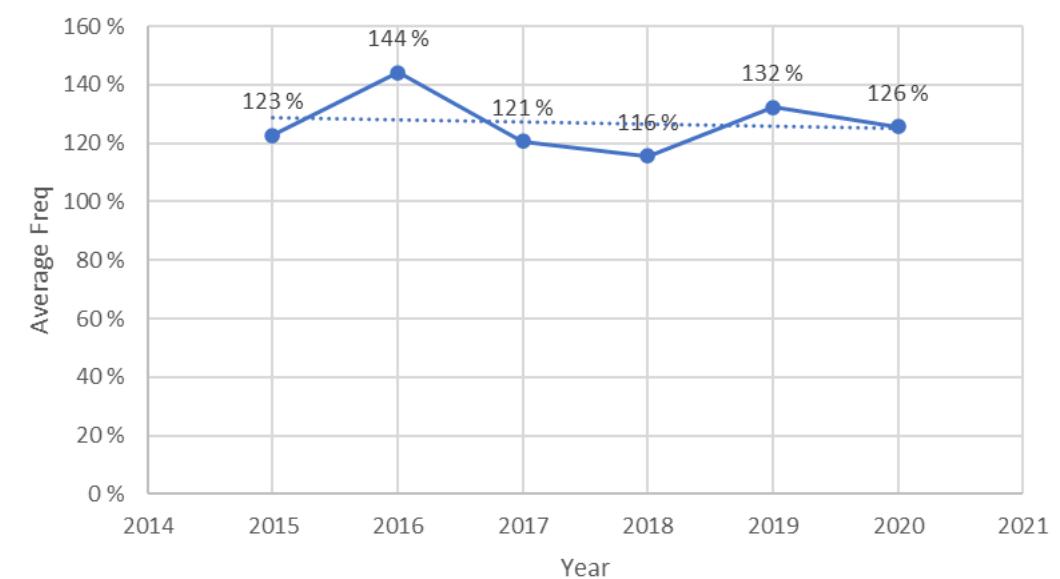
Average frequency of duration at anchor per year

A vessel with an anchor claim, spent on average 27% longer time at anchor than a vessel without an anchor claim

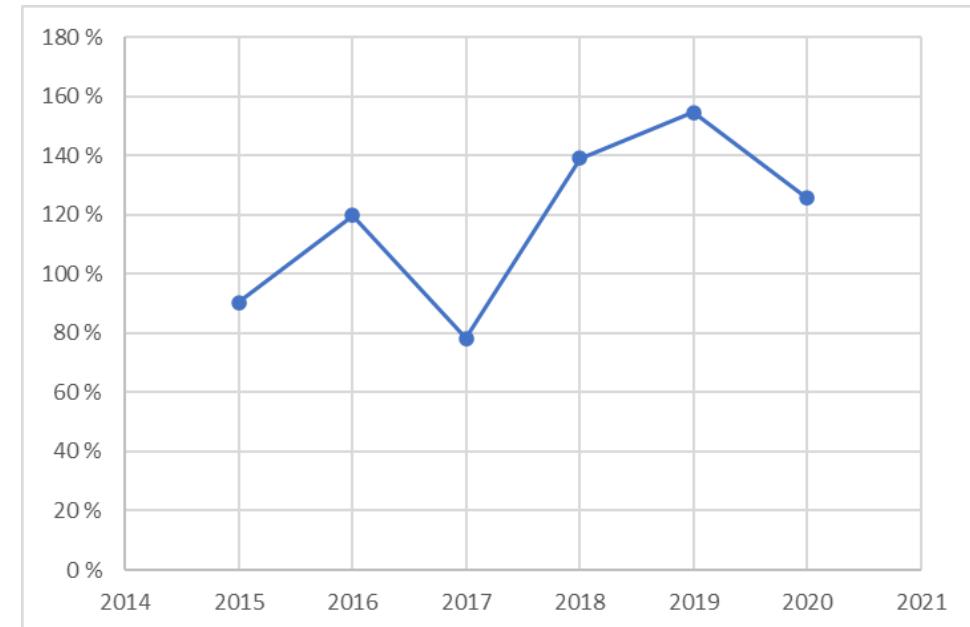
Average frequency of time spent in bad weather during the course of a year

A vessel with an anchor claim spent on average 18% longer time\* in bad weather than a vessel without an anchor claim

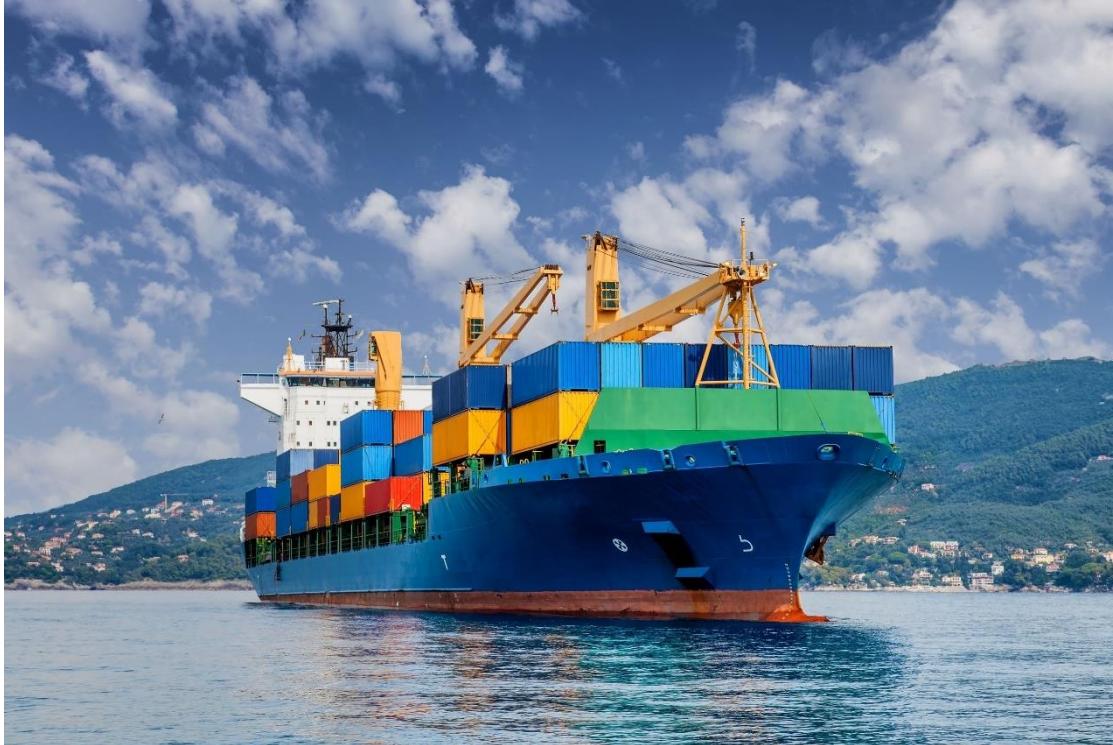
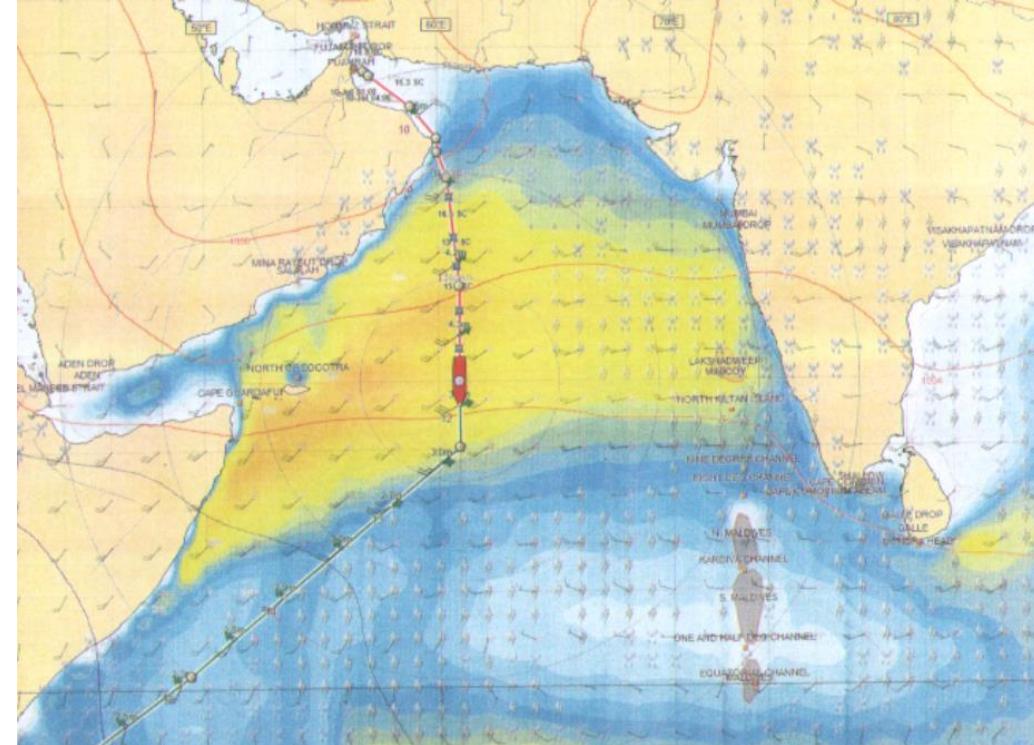
CROSSING A MONSOON WHILE UNDERWAY FROM FUJAIRA TO MOMBASA

Vessel type: 2700TEU container ship  
Class: DNV  
Length: 221m

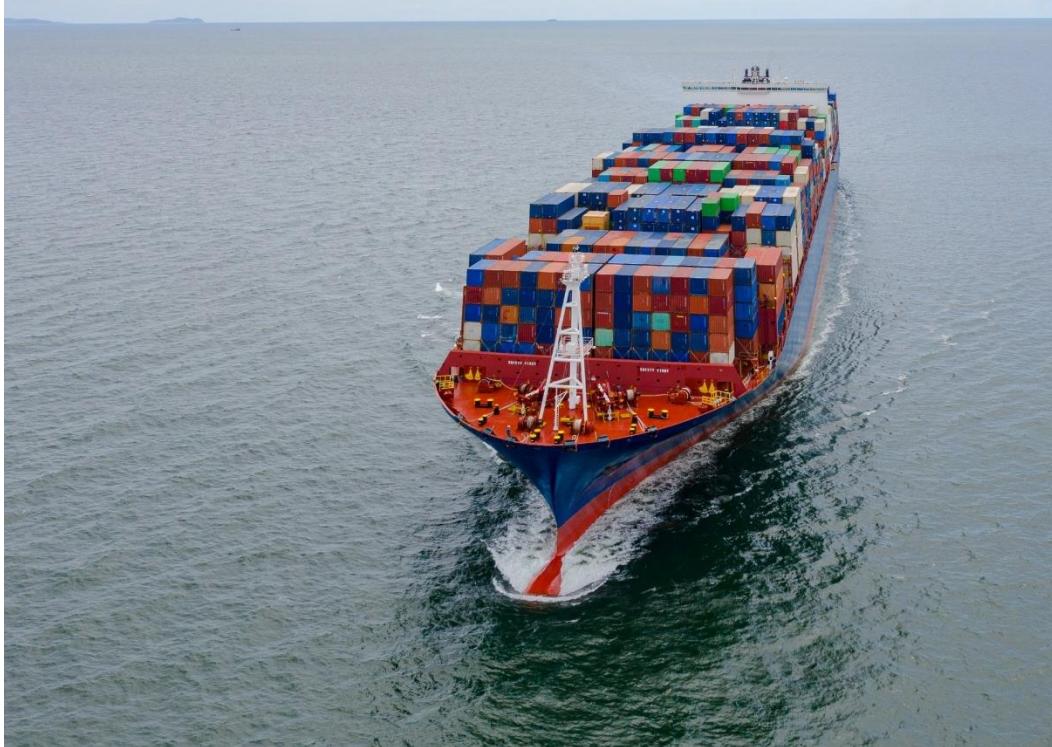
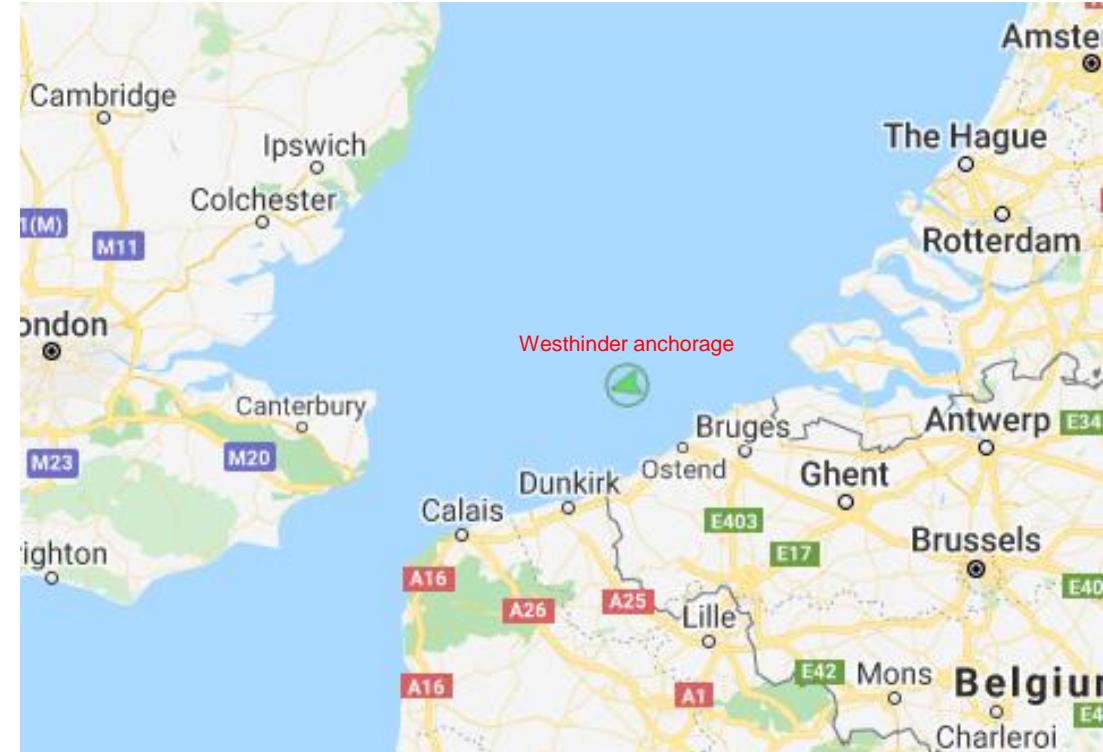
NORTH WESTHINDER ANCHORAGE OUTSIDE ANTWERP

Vessel type: 17000TEU container ship
