## Engine room fires are still a major concern

Published 13 February 2025

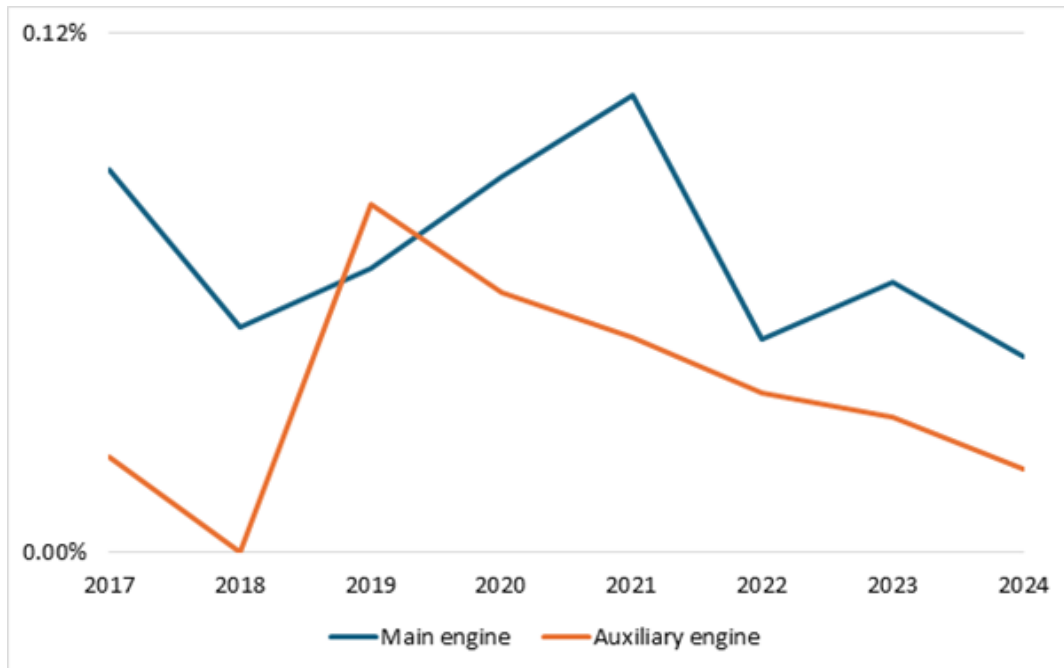
### *Frequency of engine fires (GARD H&M data)*

In Gard, when analyzing trends, we, just like [Cefor](#) (The Nordic Association of Marine Insurers), follow closely the frequency trends of incidents over a given time period. This way we are also able to account for the growth in our portfolio from one year to the next. From 2017 to 2024, main engine fire frequency has shown a slight downward trend, while auxiliary engine fires have remained steady.

Between 2017 and 2024, main engine fires occurred on an average of 0.07% of vessels annually. This translates to approximately 7 fires per 10,000 vessels each year. While this percentage may seem low, the consequences of such fires are severe, impacting human life, the environment, and causing substantial financial losses. Auxiliary engine fires were slightly less frequent at 0.04%.

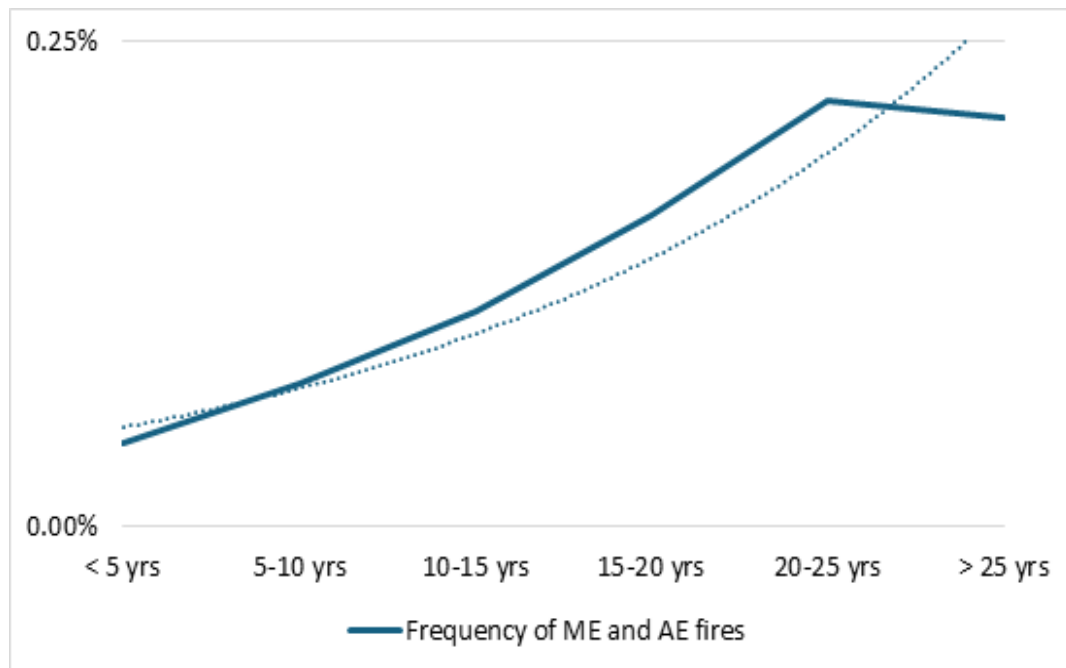
### *Frequency of engine fires by age of vessels (GARD H&M data)*

As previously discussed, vessel age is a significant factor in fire risk assessment. Our data reveals a higher incidence of engine room fires in older vessels, as shown in the graph below.

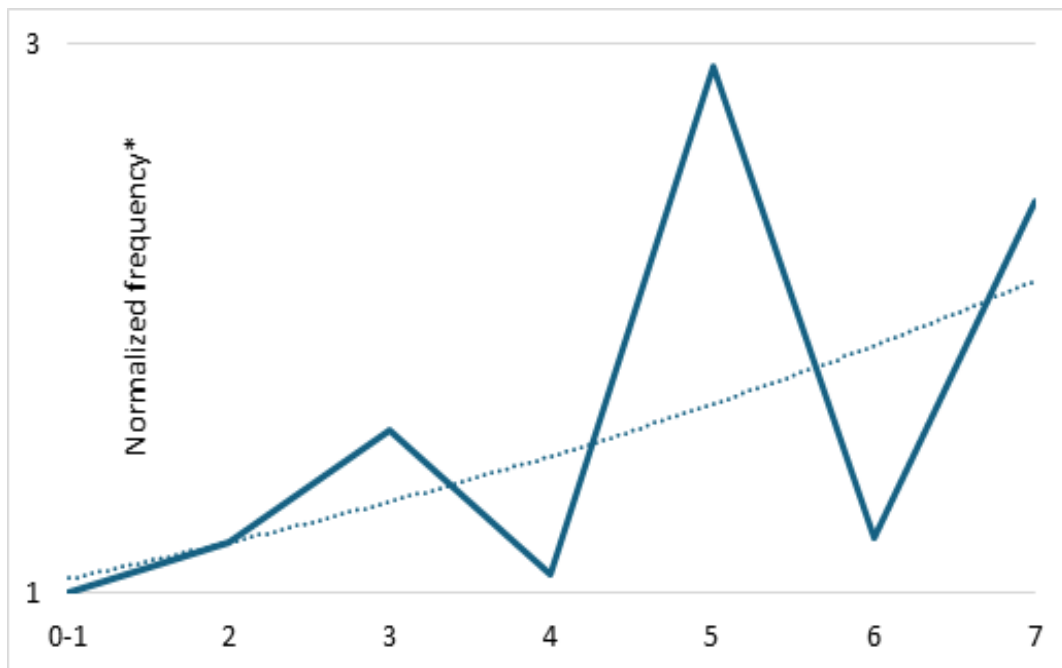
*Number of deficiencies per PSC inspection*

Ships accumulating more deficiencies per inspection over the three years preceding an incident face a heightened risk of fire in their main or auxiliary engine. This risk increases with the number of deficiencies. Numerous deficiencies might be indicative of a broader problem with maintenance on board and safety culture within the organization. It's important to note that beyond seven deficiencies per inspection, the available data becomes too limited.

*\*Note: Normalized frequency shows the relative risk of an engine fire for vessels with different numbers of deficiencies per inspection, using vessels with '0-1 deficiencies per inspection' as the baseline. For example, vessels with 5 deficiencies per inspection have nearly 3 times the risk.*
