## Engine room fires are still a major concern

Published 13 February 2025

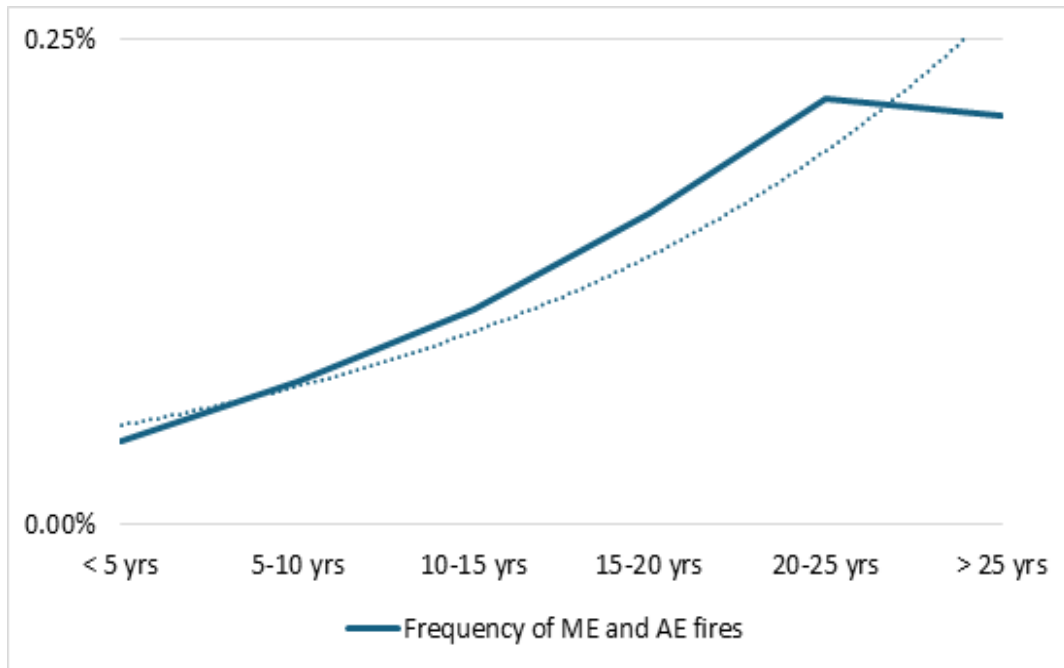
### *Frequency of engine fires by age of vessels (GARD H&M data)*

As previously discussed, vessel age is a significant factor in fire risk assessment. Our data reveals a higher incidence of engine room fires in older vessels, as shown in the graph below.

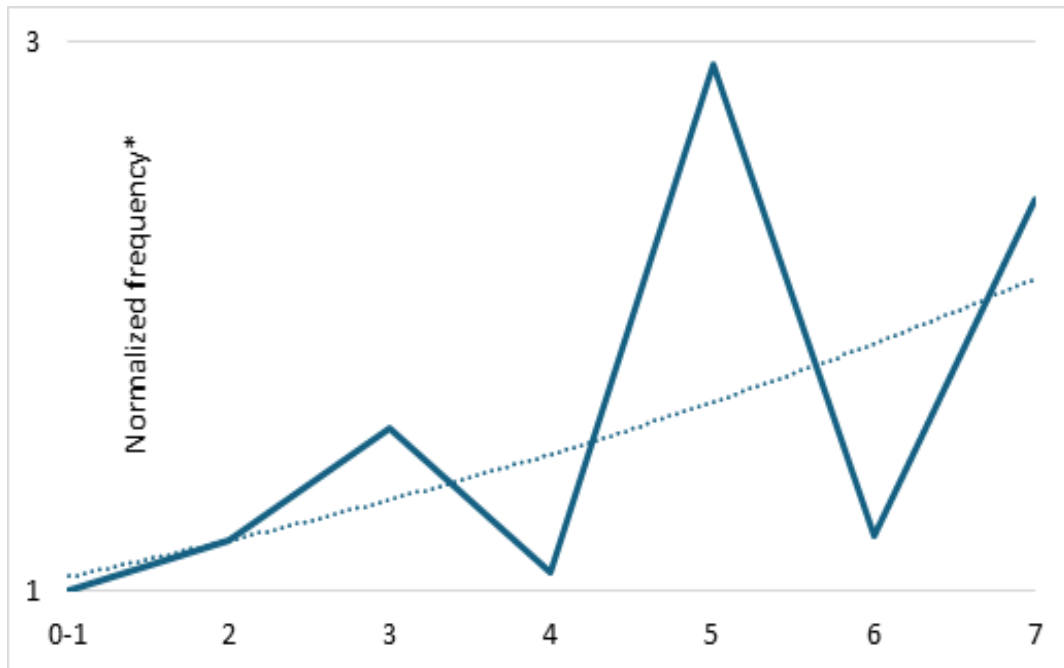
*Number of deficiencies per PSC inspection*

Ships accumulating more deficiencies per inspection over the three years preceding an incident face a heightened risk of fire in their main or auxiliary engine. This risk increases with the number of deficiencies. Numerous deficiencies might be indicative of a broader problem with maintenance on board and safety culture within the organization. It's important to note that beyond seven deficiencies per inspection, the available data becomes too limited.

*\*Note: Normalized frequency shows the relative risk of an engine fire for vessels with different numbers of deficiencies per inspection, using vessels with '0-1 deficiencies per inspection' as the baseline. For example, vessels with 5 deficiencies per inspection have nearly 3 times the risk.*
