Engine room fires are still a major concern

Published 13 February 2025

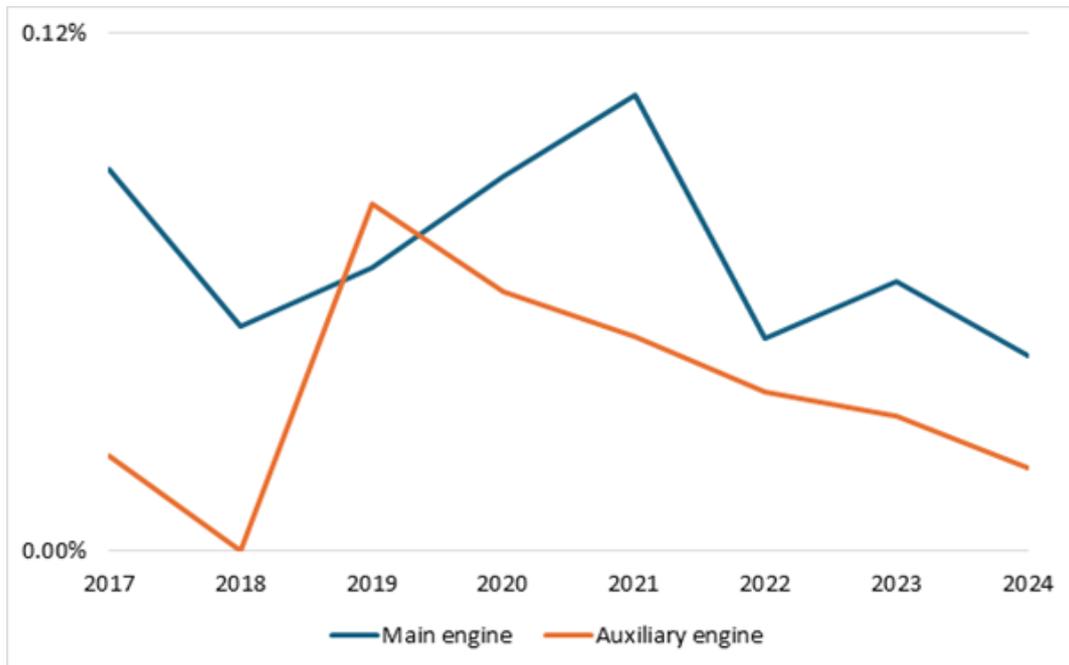
Frequency of engine fires (GARD H&M data)

Between 2017 and 2024, main engine fires occurred on an average of 0.07% of vessels annually. This translates to approximately 7 fires per 10,000 vessels each year. While this percentage may seem low, the consequences of such fires are severe, impacting human life, the environment, and causing substantial financial losses. Auxiliary engine fires were slightly less frequent at 0.04%.

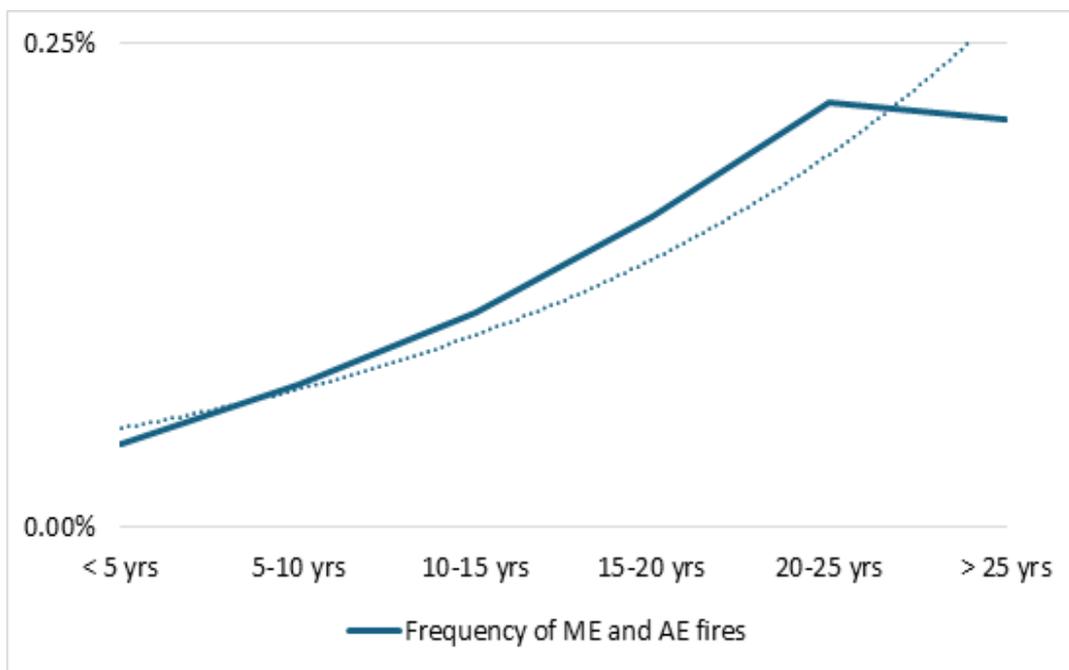
As previously discussed, vessel age is a significant factor in fire risk assessment. Our data reveals a higher incidence of engine room fires in older vessels, as shown in the graph below.

Frequency of engine fires by age of vessels (GARD H&M data)

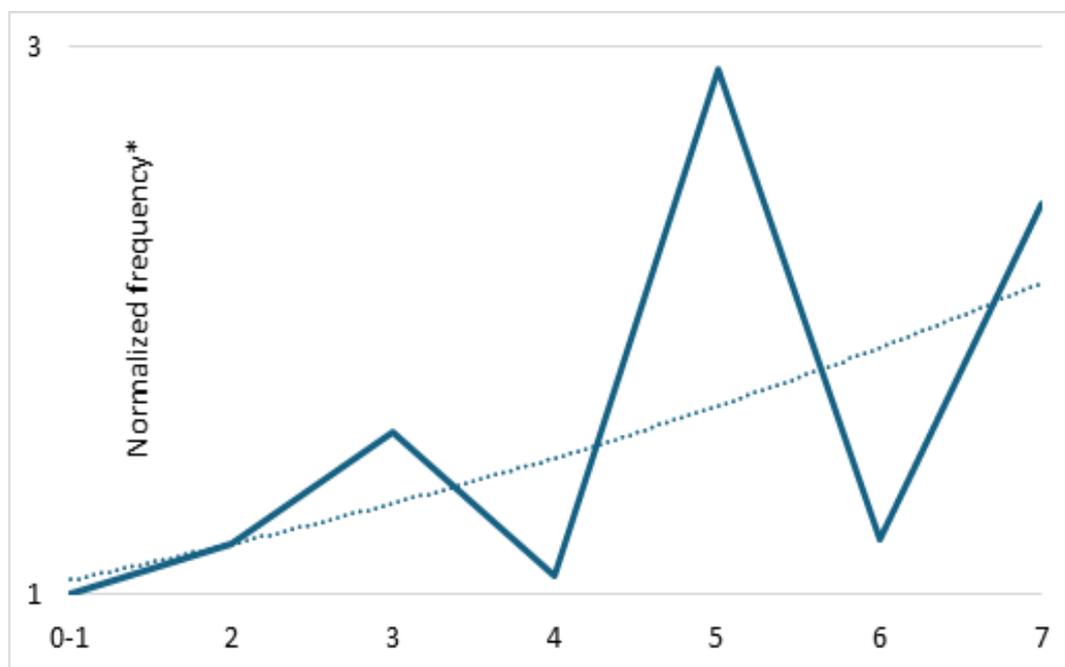
Ships accumulating more deficiencies per inspection over the three years preceding an incident face a heightened risk of fire in their main or auxiliary engine. This risk increases with the number of deficiencies. Numerous deficiencies might be indicative of a broader problem with maintenance on board and safety culture within the organization. It's important to note that beyond seven deficiencies per inspection, the available data becomes too limited.

Number of deficiencies per PSC inspection

**Note: Normalized frequency shows the relative risk of an engine fire for vessels with different numbers of deficiencies per inspection, using vessels with '0-1 deficiencies per inspection' as the baseline. For example, vessels with 5 deficiencies per inspection have nearly 3 times the risk.*
