Heat damage in soya bean cargoes - the importance of inspections

Published 26 October 2016

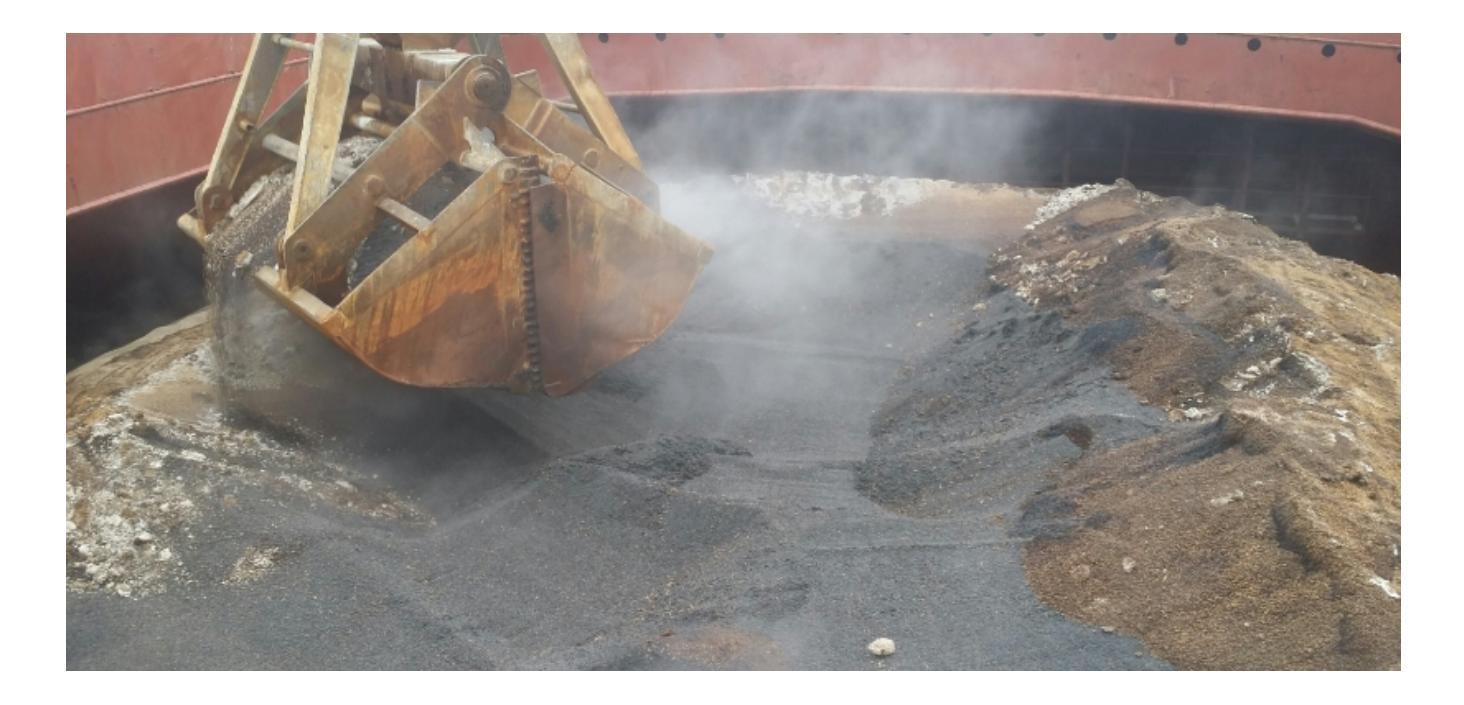
Case study – self-heating In the following example one of our Members loaded soya beans in Brazil in July 2016. The Master stopped the loading when an abnormal presence of blackened beans became apparent in the loaded stow. The Member sought advice from grain scientists and it became clear that the blackened beans (see photographs below) was due to the so-called "bin-burned" phenomenon.

From the photographs below it is clear that the blackened bin-burned beans stand out when compared to the unaffected normal yellow or pale brown beans. The binburn phenomenon occurs when over-moist beans are put into storage without sufficient aeration for long periods of time. The process starts as microbiological selfheating but, as the organisms causing microbiological metabolic self-heating die due to the effect of 'self-pasteurization', it is followed by oxidative heating of the oil contained in beans to produce the high temperatures necessary to produce the blackened bin-burned beans. Where such deterioration occurs, farmers and silo operators may break-up the affected, severely heat-damaged cargo to mix it with sound cargo delivered to the export terminals at the ports. Modern sale contracts typically allow for some 1 per cent of burnt beans. The incidence of blackened beans for the Paranagua cargo in question was significantly above this level. It rendered the affected parcels clearly out of conformity with the "normal good order and appearance" condition of sova beans that Masters expect. The presence of the distinct areas of excessive black beans was considered to present a significant risk of claims in China, which was the destination for the shipment. The photograph introducing the article illustrates how bin burned cargo can appear at the time of discharge. The Master rejected the affected parcels although they were already on board and requested they be replaced with beans in apparent good order and condition.

• The Master and crew should be vigilant during loading and monitor the visual condition of the cargo so far as practicable, using breaks in the loading for closer inspections.
