## Heat damage in soya bean cargoes – the importance of inspections

An increasing number of soya bean cargoes are reportedly loaded in a "bin-burned" condition. Important visible signs that fall under the phrase "apparent condition" can reveal at an early stage soya bean parcels that can be liable to self-heat.

Published 26 October 2016

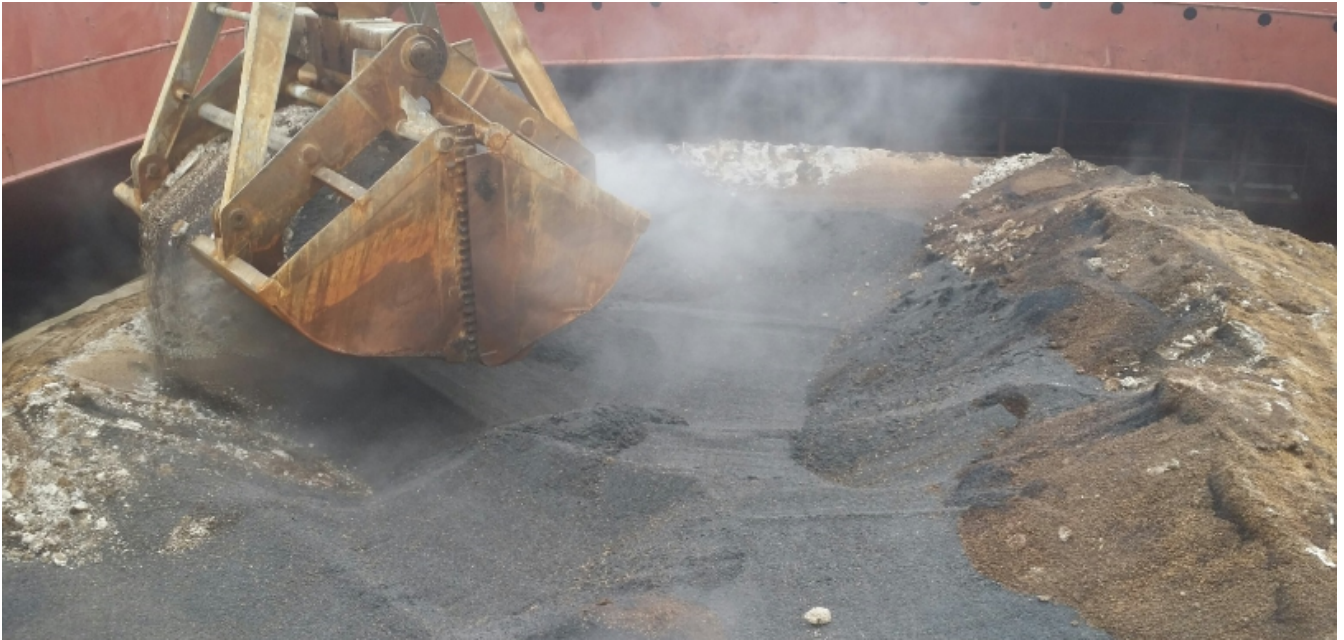
Case study – self-heating In the following example one of our Members loaded soya beans in Brazil in July 2016. The Master stopped the loading when an abnormal presence of blackened beans became apparent in the loaded stow. The Member sought advice from grain scientists and it became clear that the blackened beans (see photographs below) was due to the so-called "bin-burned" phenomenon.

From the photographs below it is clear that the blackened bin-burned beans stand out when compared to the unaffected normal yellow or pale brown beans. The bin-burn phenomenon occurs when over-moist beans are put into storage without sufficient aeration for long periods of time. The process starts as microbiological self-heating but, as the organisms causing microbiological metabolic self-heating die due to the effect of 'self-pasteurization', it is followed by oxidative heating of the oil contained in beans to produce the high temperatures necessary to produce the blackened bin-burned beans. Where such deterioration occurs, farmers and silo operators may break-up the affected, severely heat-damaged cargo to mix it with sound cargo delivered to the export terminals at the ports. Modern sale contracts typically allow for some 1 per cent of burnt beans. The incidence of blackened beans for the Paranagua cargo in question was significantly above this level. It rendered the affected parcels clearly out of conformity with the "normal good order and appearance" condition of soya beans that Masters expect. The presence of the distinct areas of excessive black beans was considered to present a significant risk of claims in China, which was the destination for the shipment. The photograph introducing the article illustrates how bin burned cargo can appear at the time of discharge. The Master rejected the affected parcels although they were already on board and requested they be replaced with beans in apparent good order and condition.

Grain experts advised that the extensive presence of bin-burn was potentially indicative of a wider problem of general over-moistness in the parcels of beans within the shipment. During the time it took to reach an agreement with the charterers to replace the affected bin-burned parcels, the cargo temperatures in all holds were checked regularly and within a couple of weeks noticeable increases in temperature were found in the accessible surface areas of the stows.
