Case study for onboard safety meeting

Near fatality when checking lashings of vehicles in the cargo hold of bulk carrier

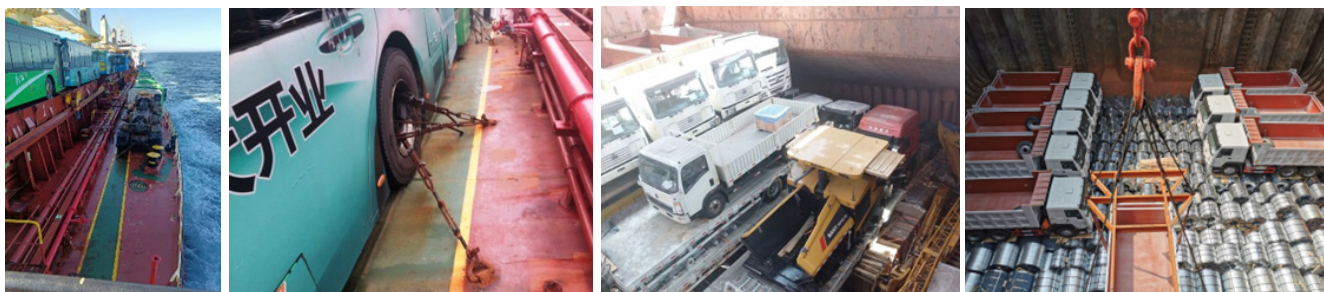
During the loading process, the Master raised several concerns. These included inadequate lashings, the risk of damage to steel coils due to the weight of the fibreboards and vehicles loaded on top of them, and the uneven loading of vehicles above jumbo bags. Despite these issues, loading was completed on 14 June, and the vessel departed Rizhao.
