## **Increase in stern tube damages – a concerning new trend?**

The number of stern tube-related damage claims has increased considerably over the last few years and such damages are now one of the more frequent claim types handled by Gard under the hull and machinery policies. A recent Gard analysis sheds light on the problem.

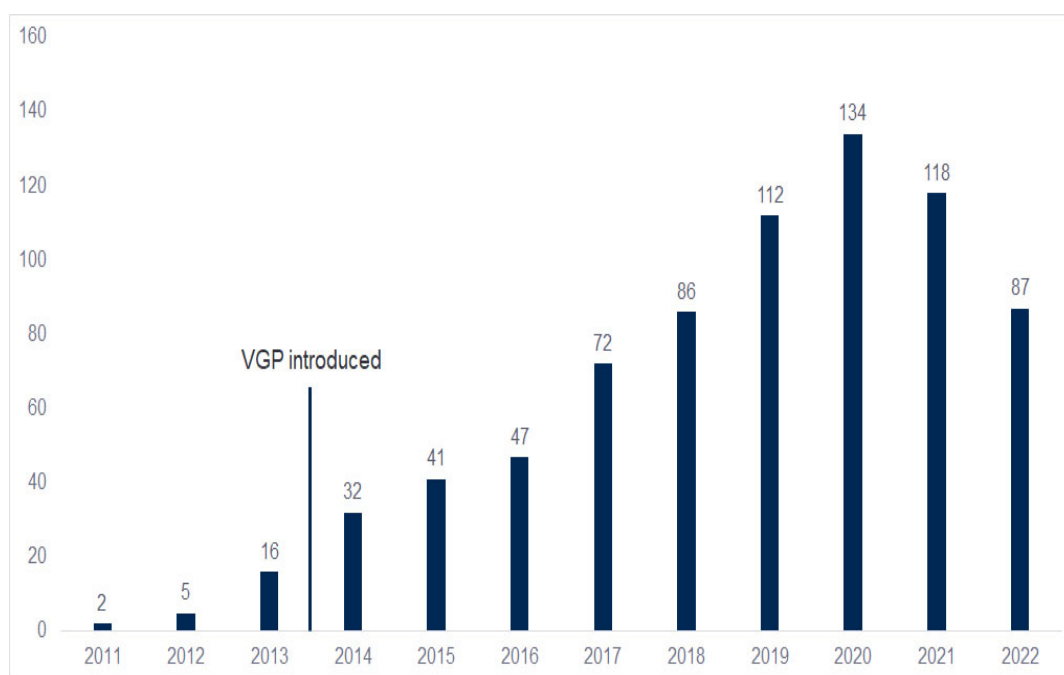
*Total stern tube-related claims in Gard in excess of USD 5,000*

*Source: Gard*

Over the last decade, the number of shaft / stern tube-related claims Gard has handled, either as claims’ lead or on follow accounts, exceeds 700 with the below spread over the years:

As shown in the first bar graph, the significant increase in claims seems to have followed the introduction of the revised Vessel General Permit (VGP) requirements in 2013 by the U.S. Environment Protection Agency (EPA). These require all vessels over 79 feet trading in U.S. waters to use Environmentally Acceptable Lubricants (EALs) in all oil-to-water interfaces.

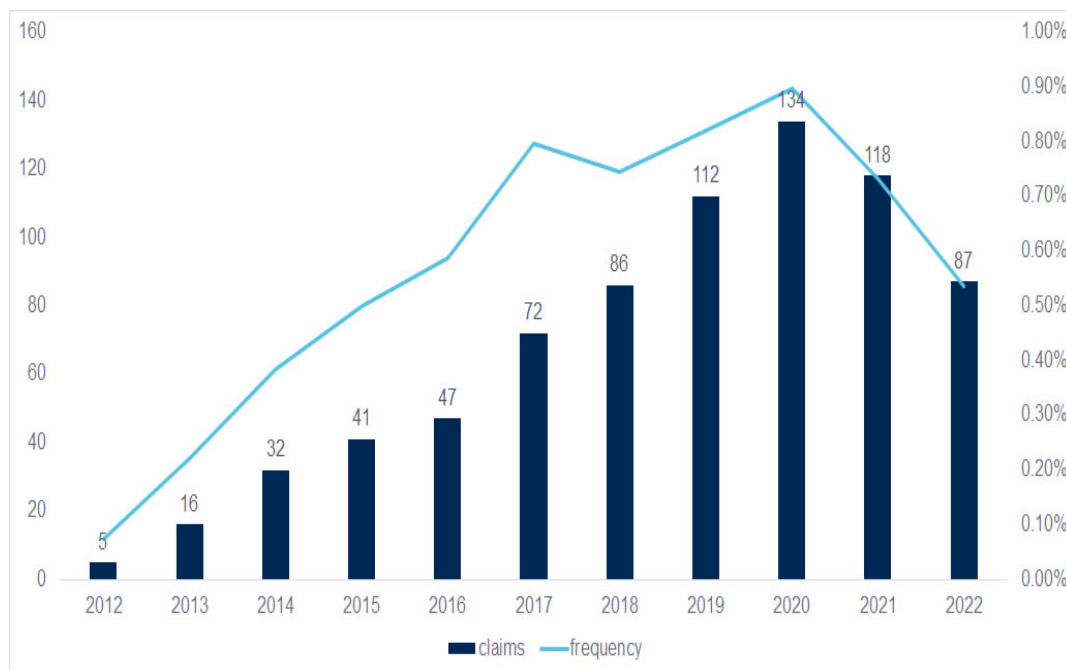
*Frequency of the stern tube-related claims in Gard in excess of USD 5,000*

To be clear, over this same period of time, the number of vessels insured with Gard has also increased. So, is the increasing number of claims just reflecting the higher number of vessels insured? No. Even when taking into account the total number of vessels covered, we still see that the share of stern tube-related damages is increasing (see chart below).

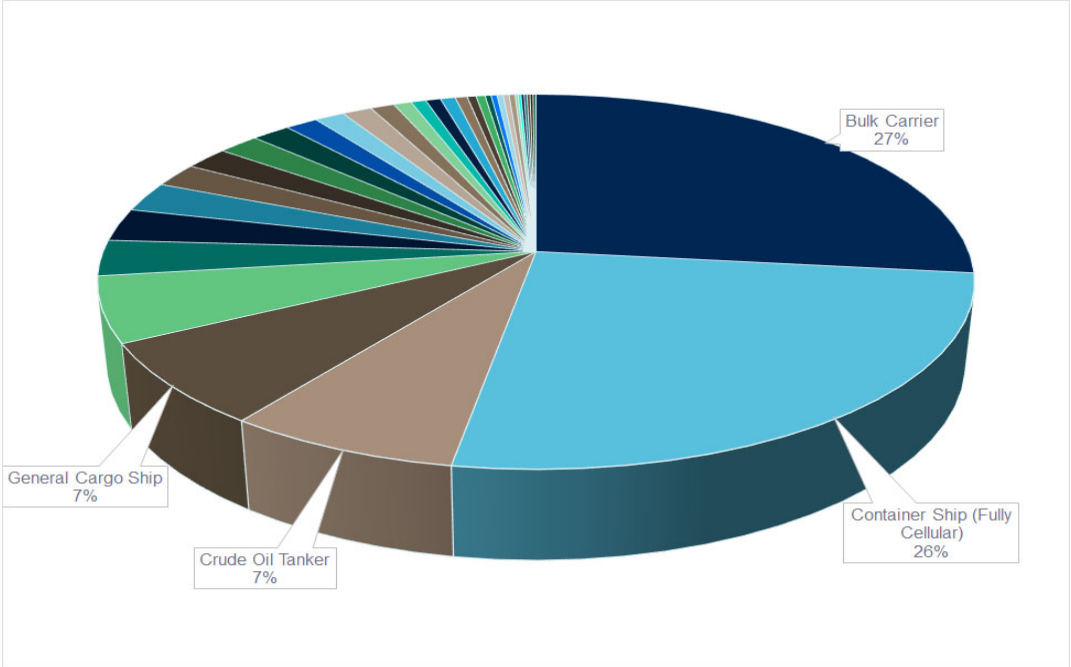
*Stern tube-related claims in Gard, by vessel segment*

It was evident from the start that the type of vessels that suffer most from such damages are Bulk and Container Carriers, accounting for 53% of the occurrences. In total, these segments make up 44% of Gard's Hull and Machinery portfolio (see pie chart below).

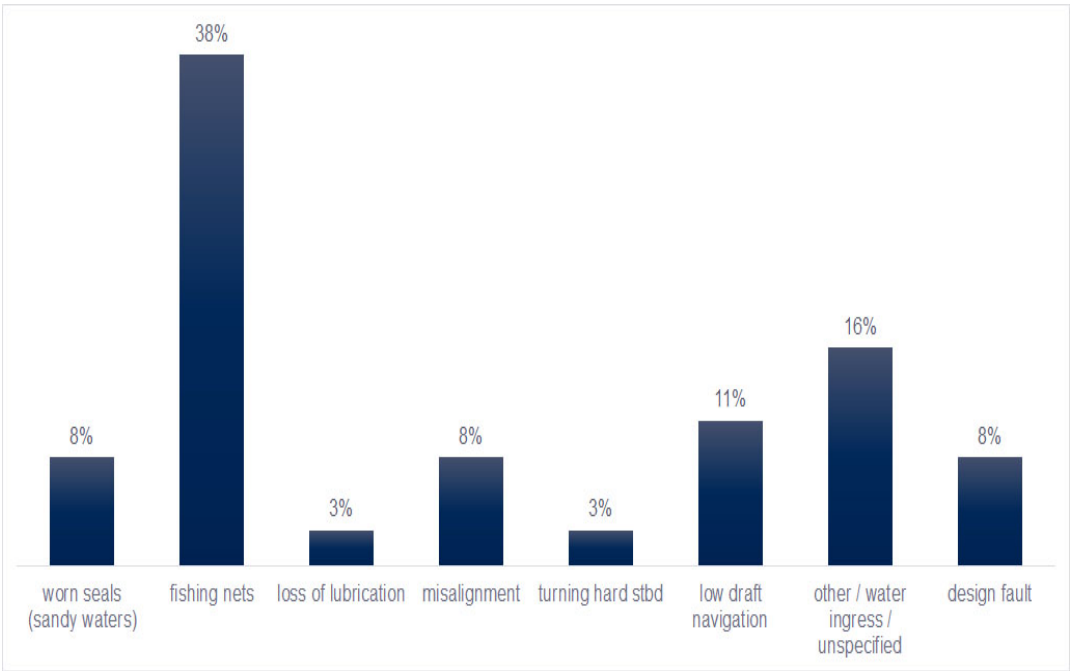
The root cause investigation was thus narrowed down to focus on Bulk and Container Carriers, with the reported causes categorized as follows:

As seen above, a large number of the incidents were attributed by the surveyors to fishnet/ropes entering the stern tube seal area causing seawater to contaminate the stern tube oil and accounting for 38% of the cases. Indeed some 500,000 – 1 million tons of fishing gear is lost or abandoned at sea every year, according to World Wildlife Fund (WWF). However, we believe that the “fishing nets causation” may have been overrepresented as the main explanation, leaving little room for further investigation into other possible factors.
