The importance of blackout awareness and prevention

Correct operation and maintenance of equipment, combined with tried-and-tested emergency procedures and crew training, are essential to prevent blackouts on ships and to mitigate their potential consequences.

Published 18 June 2025

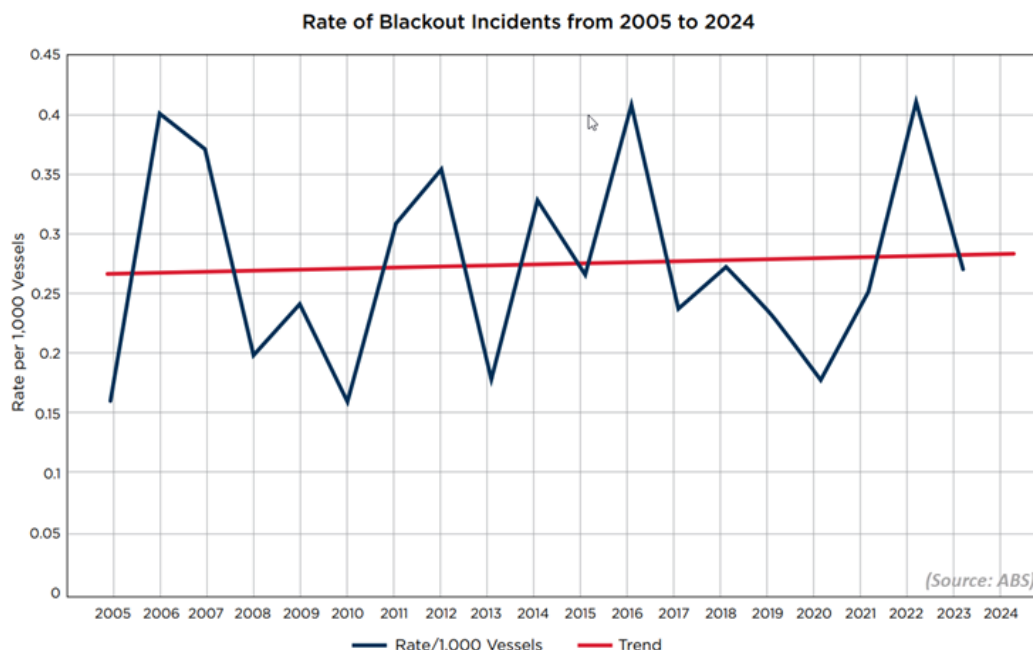
Realistic accident statistics for blackouts on ships are difficult to obtain because most blackouts are probably not reported as “accidents”. However, there seem to be some indications of an increase in event frequency. The figure below is created by the classification society [American Bureau of Shipping \(ABS\)](#) and shows a rising trend in the rate of reported blackouts in the world maritime fleet between 2005 and 2024. Similarly, research by [Det Norske Veritas \(DNV\)](#) found that in 2019, the media reported 12 power loss events on cruise ships that resulted in full or partial blackout while in transit or manoeuvring, a significant increase from four events in the previous year.
