'Cold straightening' of bent shafts may save time and money

Class-approved cold straightening of bent shafts may save time and money compared to replacement with new shafts.

Published 10 March 2020 Written by Siddharth Mahajan

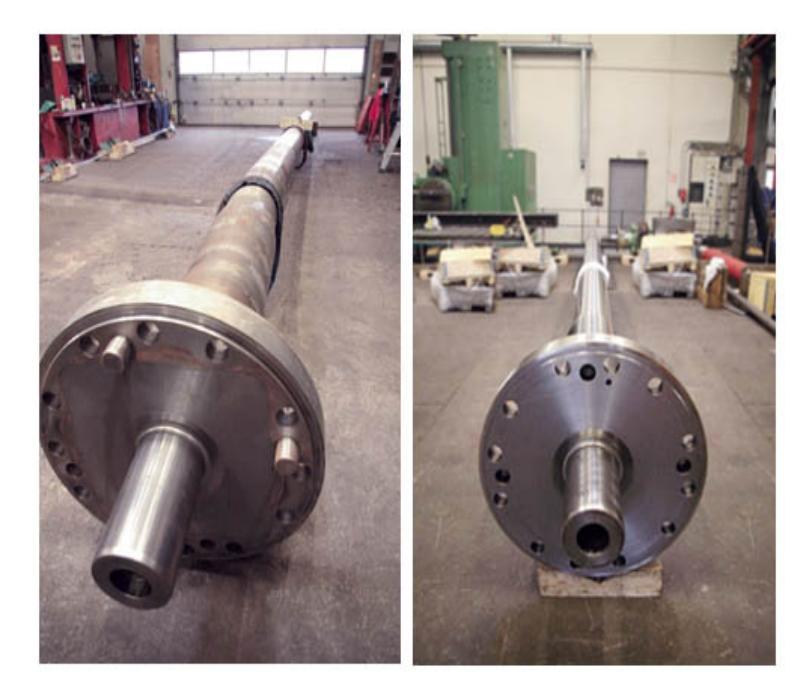
An example a bent propellar shaft before and after cold straightening.

The "cold straightening" method The cold straightening technique is more than 50 years old and has developed and improved over time. The latest technology allows straightening of shafts of all sizes - from 20mm to more than 1, 500mm in diameter and more than 25 metres in length - as well as straightening the shaft within very narrow tolerances, even more precise than when the shaft was manufactured in the first place. Cold straightening equipment consists basically of hydraulic presses equipped with numerical control and sensors for dimensional inspection of parts.

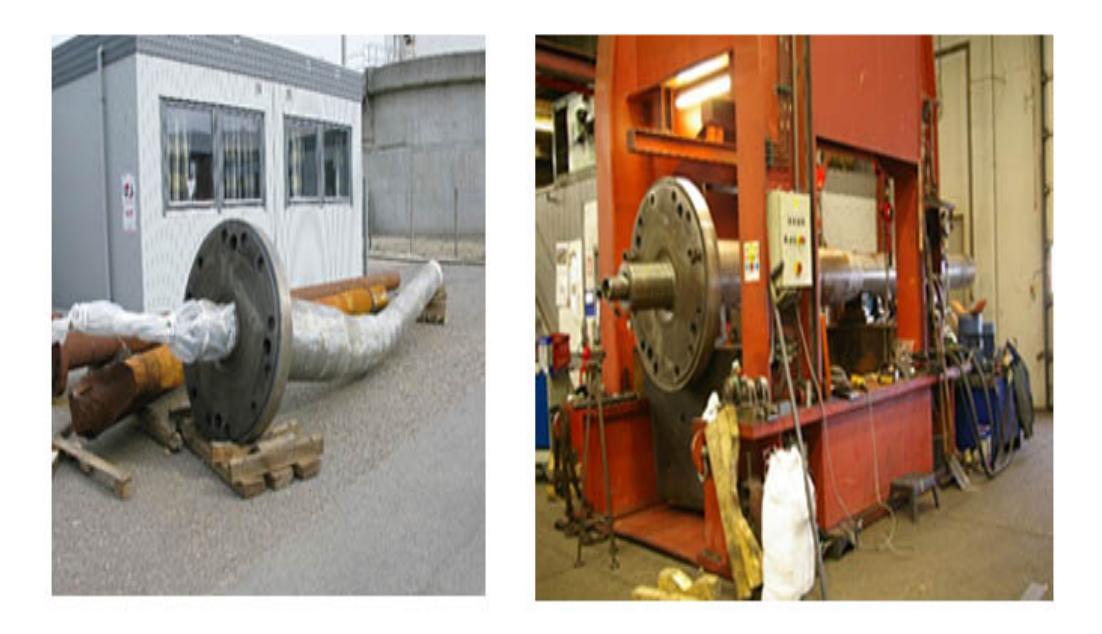
A bent propellar shaft 1 meter out of line, and after repair.

The bent propeller shaft The vessel had suffered extensive propeller shaft and rudder damage when it hit a rock off the Norwegian coast. The propeller shaft had only turned half around when it was blocked and pulled approximately one metre out of the stern tube. The vessel suffered water ingress, but was safely towed into a quay. Subsequent examination showed that the propeller shaft had suffered massive damage and was heavily bent The manufacturing of a new propeller shaft would require more than four months, Cold straightening was proposed and found to be much cheaper and faster than commissioning a new shaft. The propeller shaft was transported to the repair company in Denmark and within one week the cold straightening repairs had resulted in a 0.01mm deflection from centre line, being successfully completed to full class approval as permanent repairs without any recommendation. Later, the shaft surface was machined 1mm off and executed within the demands of class.

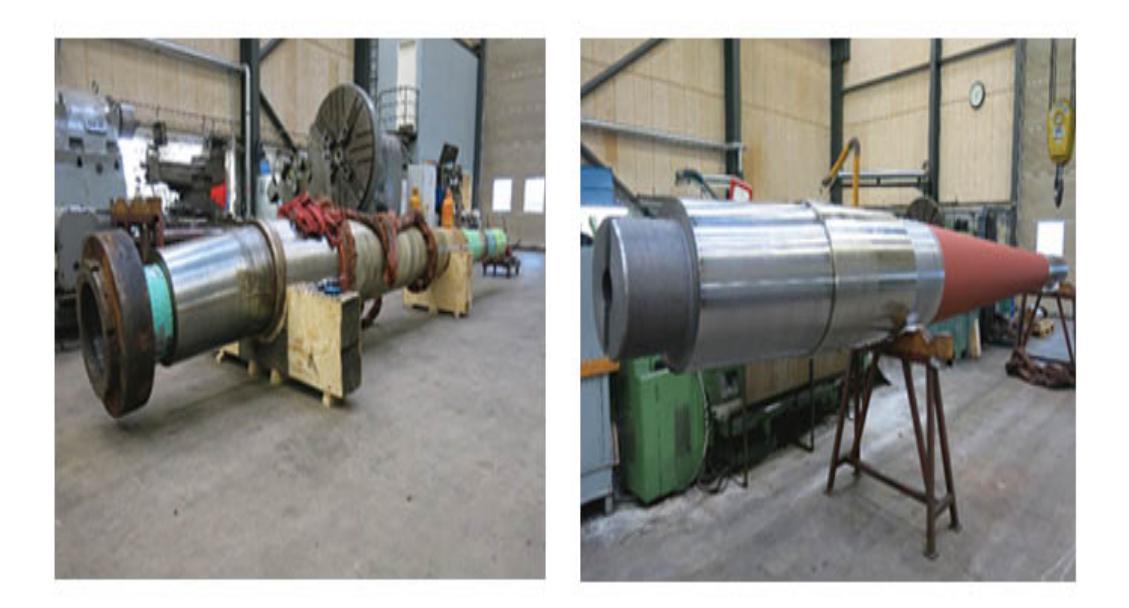
Bent rudderstock before and after cold straightening.
