## Beware of backflush filter failures – a cause of engine damage

Automatic backflush filters are designed to protect engines by keeping fuel and lubricating oil clean. However, Gard's recent claims experience shows that when these filters fail, they can become a serious source of engine damage, with potentially costly and time-consuming consequences.

Published 12 December 2025

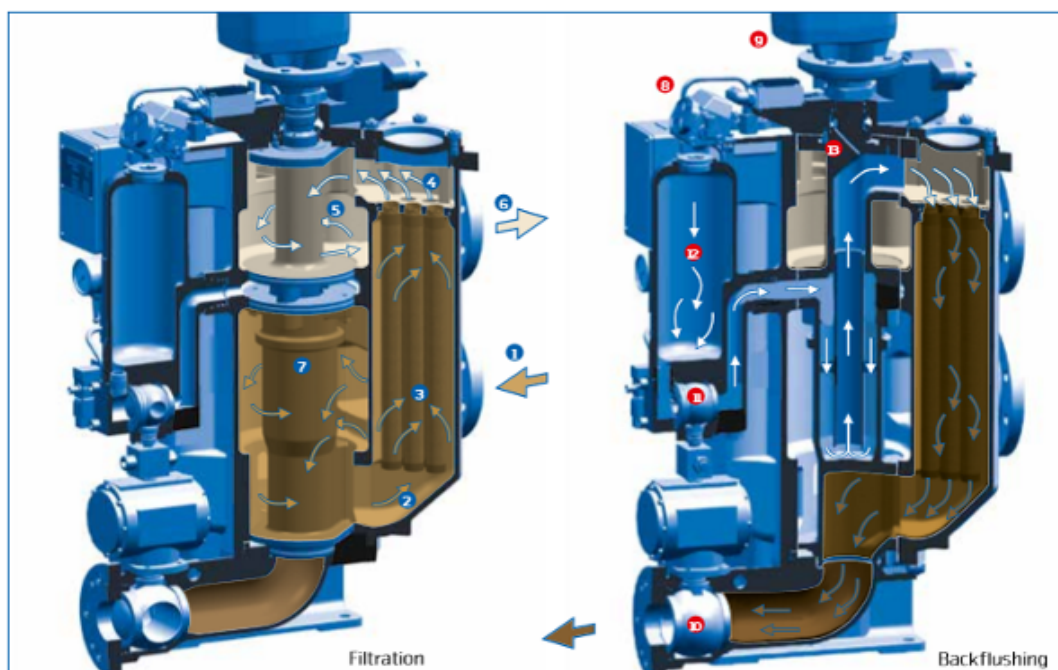
The difference compared to traditional filtration is the backflush sequence, which is normally pressure triggered, dependent on make and type of your installation. When the differential pressure reaches a set value the filter compartment closes and the oil flow stops. Simultaneously, a new chamber opens to allow continuous filtration and engine operation. Air is then forced through the closed chamber, rinsing the candles before the chamber is then refilled with clean oil and set in standby for further operation (as illustrated by the graphics below).

*Source Boll & Kirch Filterbau GmbH.*

Automatic backflush filters for fuel and lubricating oil cleaning have been in operation for many years and have become common in many engine installations. The filters generally consist of one or more chambers with a set of candles of fine wire mesh that the oil flows through. Larger particles get stuck on the surface while smaller particles flow through the filters and back into circulation.

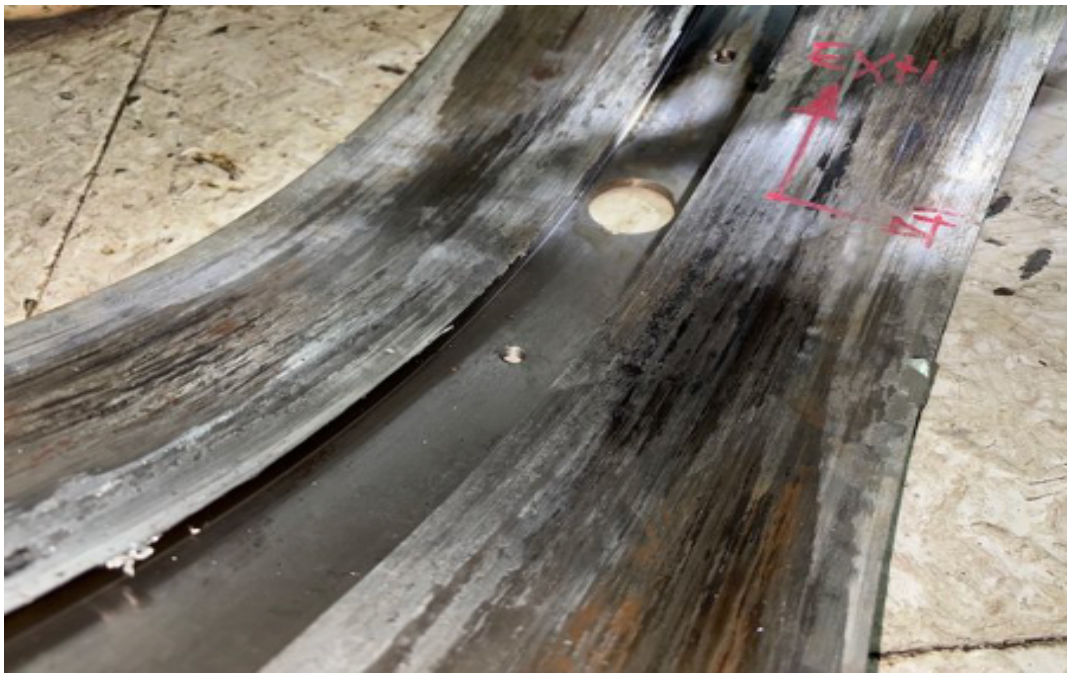
The small wires of the mesh break off and can travel through the entire lubrication system, causing severe damage. This damage will be primarily located on bearing surfaces on camshafts and crankshafts. This will in turn create severe surface deterioration and breakdown that can damage the engine even further and lead to dangerous situations . Replacement of main bearings and even the crankshaft itself can be very expensive and time consuming. In one Gard case, replacement of a crankshaft is expected to cost 2.2 million USD with a 8-12 week period just to source the new equipment.

*Bearing with severe damages from debris.*

Where deterioration of the mesh is found, mechanical and chemical cleaning of the entire system affected will be required prior to operation. If the cleaning process is substandard, new damages may arise swiftly after repairs have taken place.

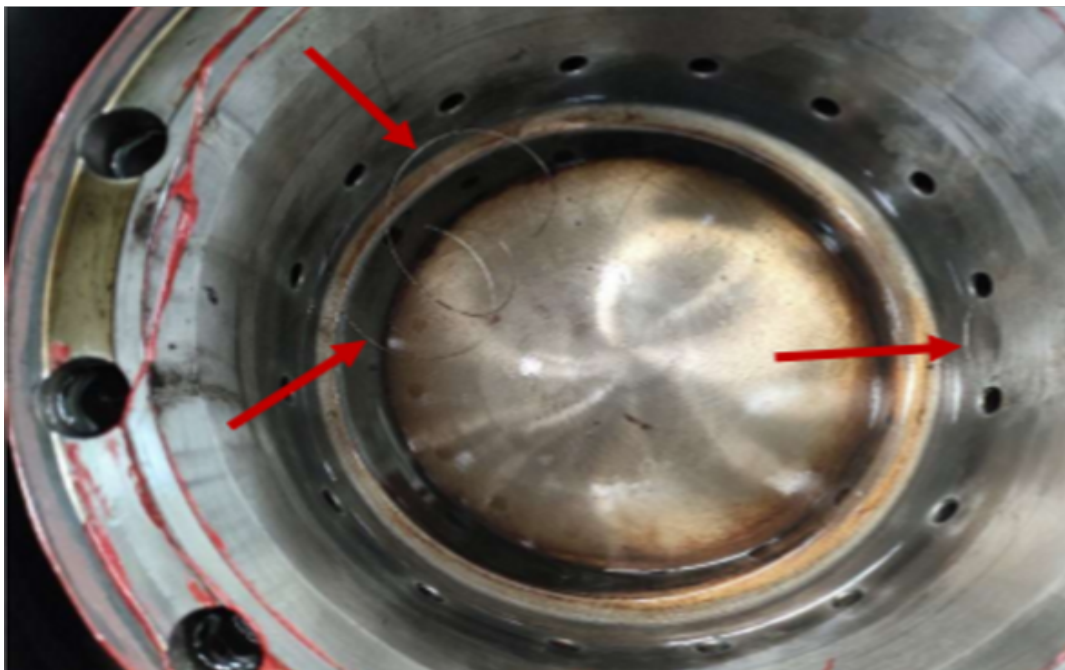
Depending on the make and type of your filters, maintenance requirements will differ. In the matters seen by Gard, disintegration is either due to mechanical damages from rough handling by the crew or old candles having suffered excessive rinsing cycles and use beyond the expected lifetime. The lifetime is determined by shelf-life storage conditions, rinsing cycles and handling.

*Filter mesh started to disintegrate.*

- The engine crew should be trained to spot even minor damage to the candles. Training on how to handle the filters with care during cleaning is vital. We recommend having cleaning tools onboard like an ultrasonic cleaner unit or cleaning gun which blows horizontally onboard,

- If not already installed, a strainer or in-line filter should be installed after the backflush filter to ensure debris from candle disintegration is captured before it contaminates the oil system.

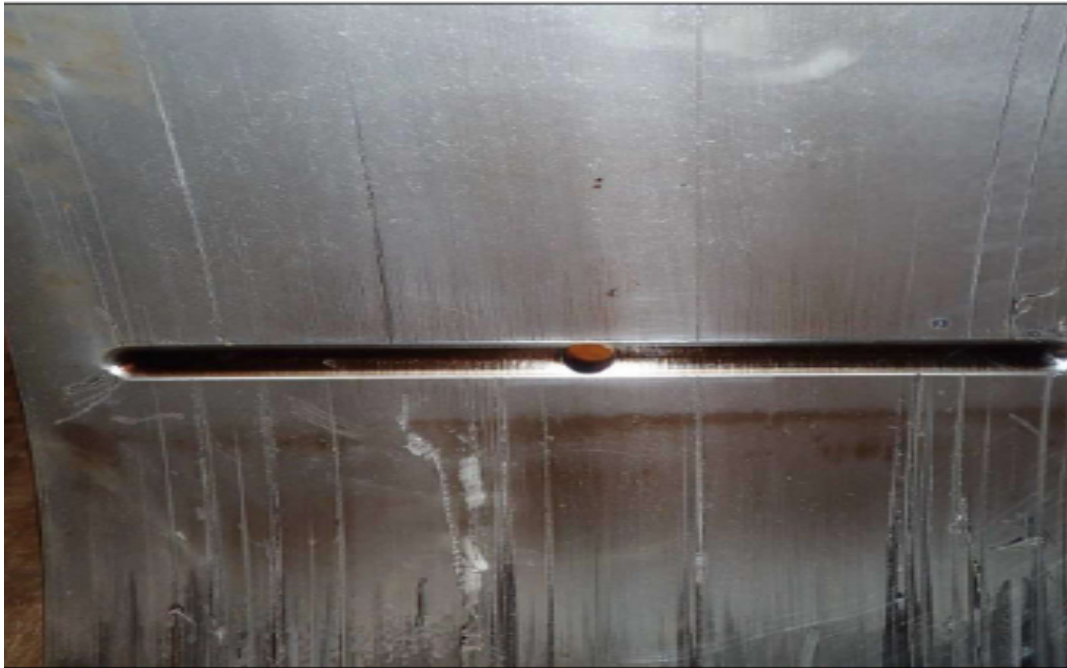
*Filter wire damage to main bearing.*
