Liquefaction of chromite ore originating from South Africa

Despite being categorized as a 'Group C' cargo in the International Maritime Solid Bulk Cargoes (IMSBC) Code, Gard's recent experience in South Africa suggests that chromite ore may exhibit Group A properties including the potential to liquefy.

Published 13 May 2025

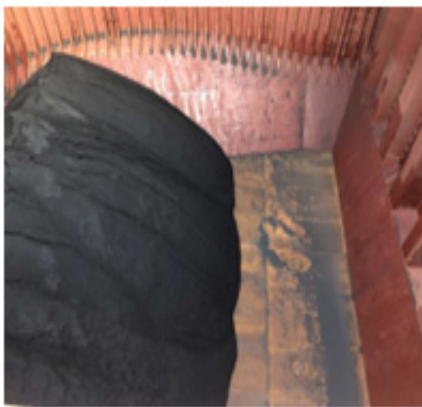
The vessel had loaded a parcel of Chromite Ore at Durban in cargo hold no. 1 and proceeded to sea while waiting for subsequent parcels to be loaded. The cargo had been declared as Group C with no declared moisture content (MC) and transportable moisture limit (TML). While waiting for further cargo, the Master reported that the cargo was showing signs of liquefaction. Investigations revealed that the cargo was fine particles and had flow potential. Recent heavy rains likely contributed to the elevated moisture content in the stockpiles, which were exposed to the elements. The shippers provided an updated cargo declaration, where the name of the cargo was amended from “chromite ore” to “Chromite Ore (metallurgical grade concentrate)” and Documentation for MC and TML was provided as well, although the cargo was still declared as Group C. The vessel was subsequently detained by South African Maritime Safety Authority (SAMSA). The detention note stated *“Cargo had shifted rendering the vessel unseaworthy, and cargo information provided before loading did not match the cargo loaded onboard”*.

Upon completion of loading first parcel

- The cargo surface should be trimmed completely flat on completion of loading to minimize the risk of the cargo shifting.
- During the voyage, the crew should regularly check the condition of the cargo. Any sign of cargo liquefaction such as flattening, shifting, free surface water, or vessel instability be seen as a need for urgent assistance not limited to seeking safe anchorage.

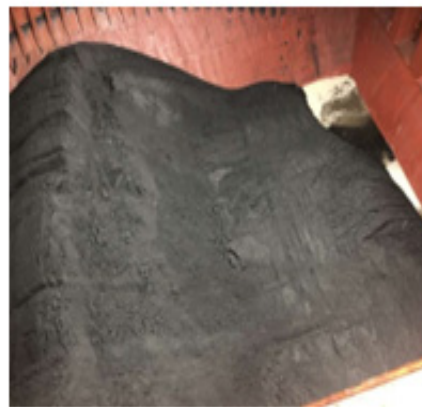
Cargo surface flattened and water accumulation noticed a day later

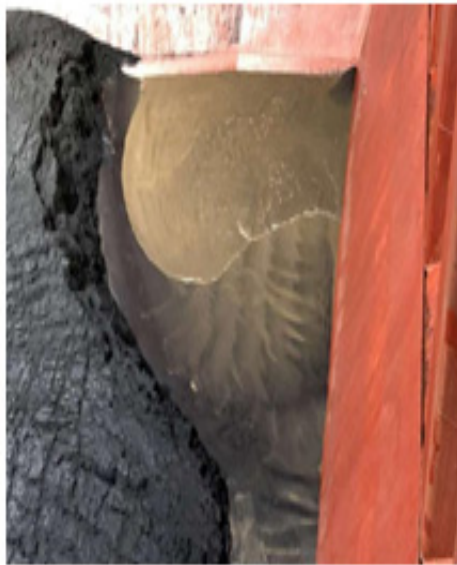
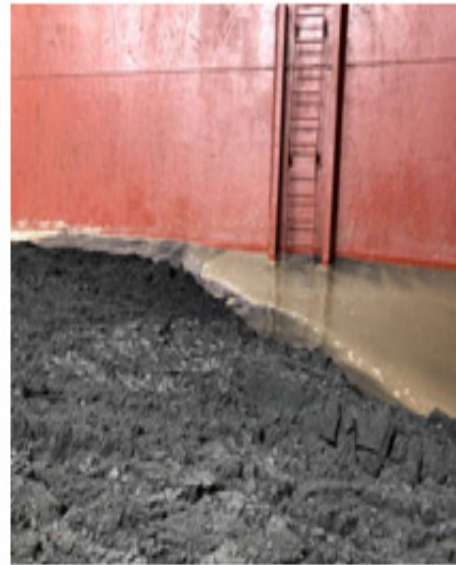
The vessel loaded Chromite Ore at Durban and departed for Maputo. On arrival Maputo, it was noticed that there was a substantial amount of water collected in the corners of the stow in all cargo holds. The presence of muddy and liquefied cargo indicated that the cargo was Group A and not the Group C as was indicated on the shipper's declaration.

- It is crucial to engage charterers in early discussions if your vessel is nominated to carry chromite ore, as a cargo declaration classifying it as Group C may not be accurate, as seen in the above examples. The cargo may appear to be dry and granular when shipped, however, it may be prone to liquefaction at a subsequent stage. Some signs to look for:
splatter on the bulkhead of the cargo holds,
failed can tests,
fine nature of chromite ore cargo,
recent rainfall in the port,
MC & TML certificates provided but cargo still declared as Group C. Refer to our topic page on [liquefaction](#) for further details.
