Container carriage

A selection of articles previously published by Gard AS

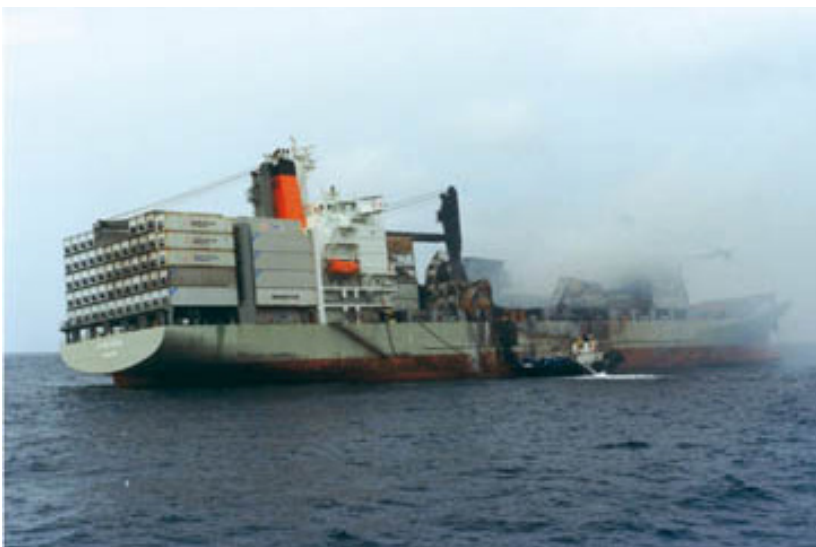
The ACONCAGUA: the entirety of the cargo was destroyed by the initial fire and explosion.

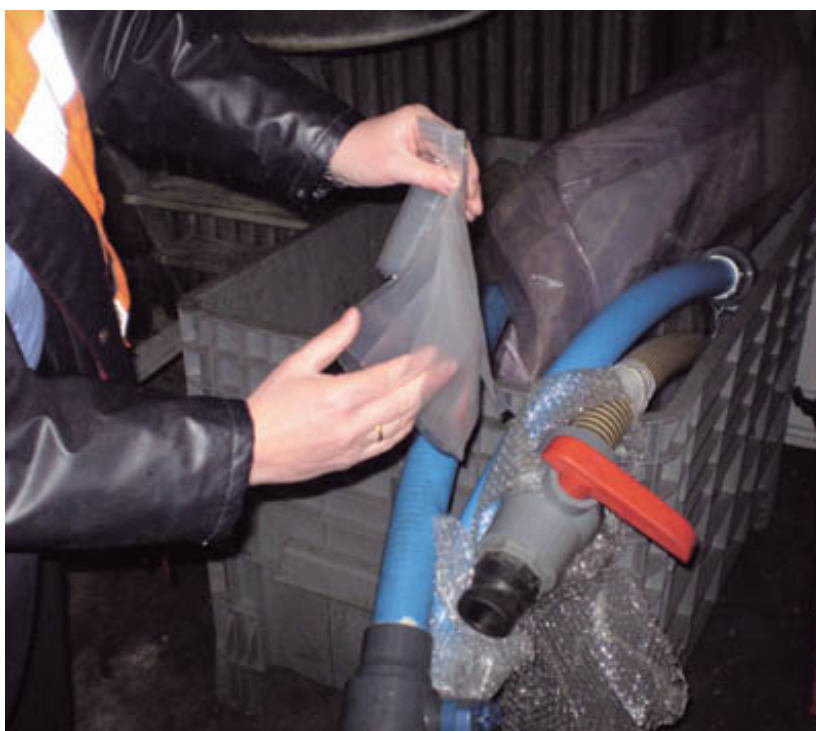
Example of a five-ply plastic flexi-tank.

Flexi-tanks are made of nylon, rubber, plastic or polyethylene, a flexible "inflatable" bag type, which is rolled out inside a conventional 20-foot dry freight container, before being filled with the liquid cargo through a valve opening either on top or at the bottom end at the dry freight container door. In compressed, empty condition the flexi-tank itself will occupy only a volume of 250 litres, but in loaded condition may contain as much as 24,000 litres of liquid, depending on the specific gravity of the liquid. The use of flexi-tanks started around 2003, the initial

- Cheap single layer bags made of plastic or polypropylene. These may be very vulnerable to cuts, which can lead to the partial or complete loss of the cargo.
- More expensive multi-layer bags consisting of five to six-ply polyethylene and a polyethylene fibre woven outer mantle. These are stronger and more resistant to damage than single layer bags.
- Rubber bags.

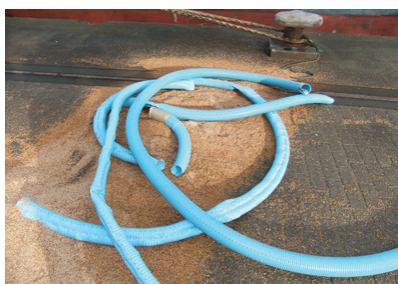
Plastic tubes used for aluminium phosphide tablets, pulled out after discharge of the cargo holds.

favourable conditions for complete release of phosphine from the tablets are in tropical and subtropical climates, where four to five days are sufficient. In temperatures below 15°C, or in a very dry atmosphere, much more time would be needed. If the tablets are only spread on top of the cargo, it will also take time for the gas to spread through the full depth of the cargo, although the gas is heavier than air. Tablets may therefore be placed in tubes penetrating the cargo depth and the gas spread by a fan or pushed into the cargo by probes, etc., to speed up the process.

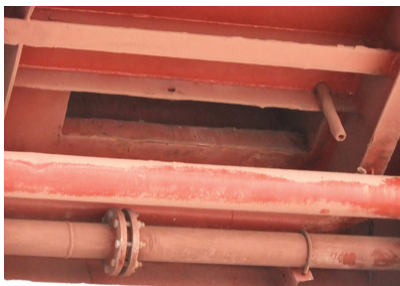
Ventilator opening in deck at the aft bulkhead of cargo hold No. 3. The steel bulkhead is the common boundary between the accommodation and the cargo hold ventilator.

accommodation and next to the captain's office. When the lining of the office was pulled down, a small corroded hole was found in the front bulkhead. That steel plate was the common boundary with the aft ventilator from the aft cargo hold. Corrosion within the ventilator over many years had made a small opening for the gas in the cargo hold to pass to the insulation of the accommodation walls. The extraction fans from the toilets created a slight under-pressure, sufficient to draw the gas, which escaped to the cabins wherever there was an opening. The sad truth is that the seaman would most probably have survived if he had not been told to rest in his cabin, and had instead been placed in fresh air.

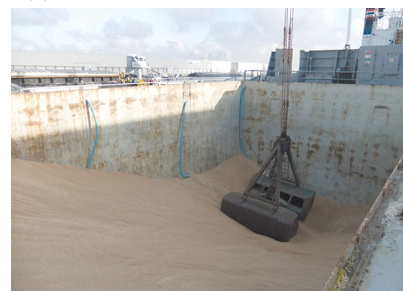
Grain being unloaded from cargo hold. Three out of six vertical plastic tubes can be seen. The aluminium phosphide tablets were placed into these tubes after loading. The tubes had small holes, but contact between cargo and tablets was probably insufficient so it took a full month for the fumigation to be completed in this case.

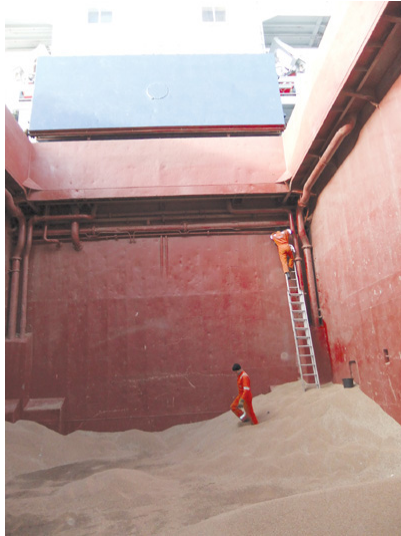
Aft bulkhead of cargo hold No. 3. The ventilator opening is in the corner, above the ladder. Access is difficult, as it is behind pipes under deck.
